AW: Replacement capacitor

Just going back to this issue about the failing gold cap capacitors on the Ceratherm 600-3.

Subject: Replacement capacitor

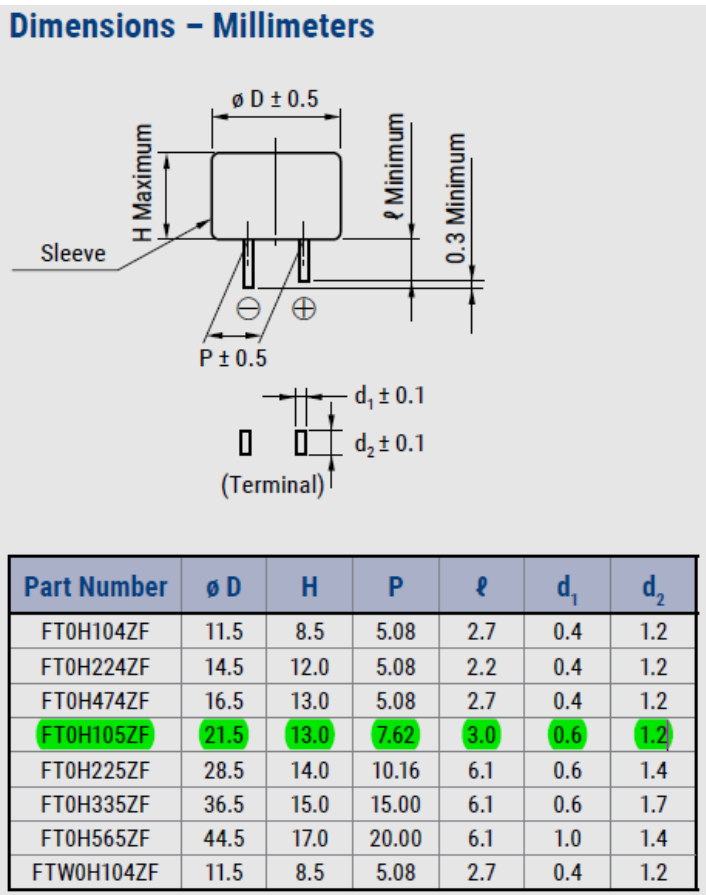
The product is basically suitable. The requirement criteria are fulfilled. Regarding capacity (1.0 F) and the connection pitch (7.5mm), this type would have to be selected:

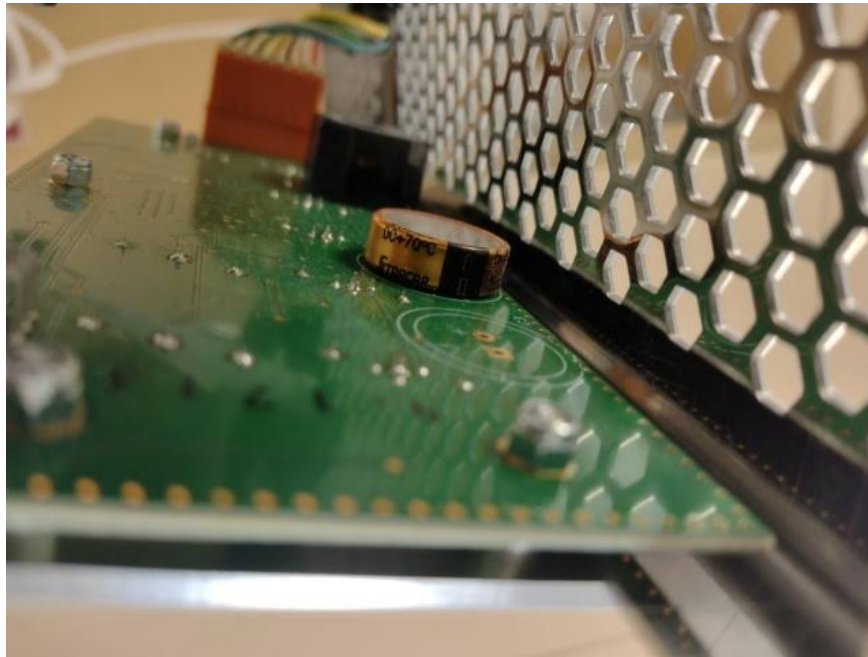
These Supercaps already have large capacity tolerances (>20%) when new. Over the years, they also lose capacity due to ageing (temperature and voltage are driving factors for ageing). For this reason, the standard also specifies these ten minutes.

As you have already found out, these gold cap capacitors take a long time to fully charge compared to normal capacitors.

Due to their age, I would imagine that the capacitors need a little longer to be fully saturated.

During the charging process, capacitors are charged, which in turn charge the capacitors further back and so on. For this very reason, it is important that the gold cap is given sufficient time to fully charge. Sufficient means between 5 minutes and more. A Gold Cap that is only partially charged loses its charging voltage quite fast after the voltage source is switched off.

All 6 devices failed to meet the requirement of the power disconnect alarm sounding for 10 minutes without power.

Looking at the PCB, we can see that there is a capacitor on there. I don't have a wiring diagram but it seems very likely that this capacitor could be storing the charge to maintain the alarm in the event of a power failure.

However, the customer can replace the energy storage device (super capacitor) if necessary. This component can be procured on the market (available from various manufacturers) and must comply with the following specifications:

Super Capacitor (C16 on CPU-Board)

Capacity: **1.0 F**
Dielectric strength: **5.5 V**
Temperature range: **85 °C**

Pitch: **7.5 mm**
Diameter: 20mm (other dimensions possible)
Height: 11mm (other dimensions possible)

Would a simple replacement of this capacitor fix the problem? And if so, do you supply it or can you give me the capacitor specification so that we can try it?
