# Analysis of complaints & Customer Feedback

Investigation into Viamed P867RA  
Adult Finger Probe under read on  
Ohmeda 3800 oximeter.

23rd April 2002

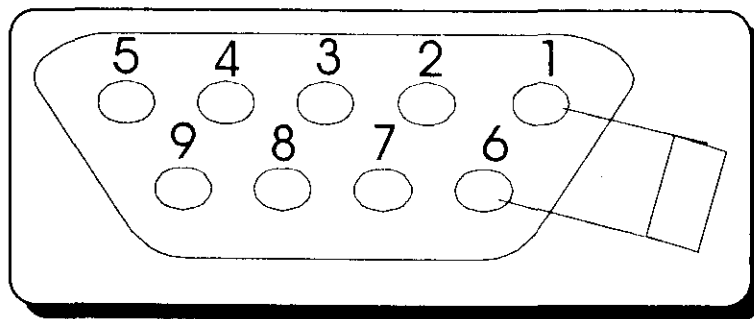
The P856RA has inner and main screen connected to Pin 7. This is also true for Epic

The Original Nellcor has the inner screen separately connected to Pin 6. The inner screen is not connected at the finger clip end.

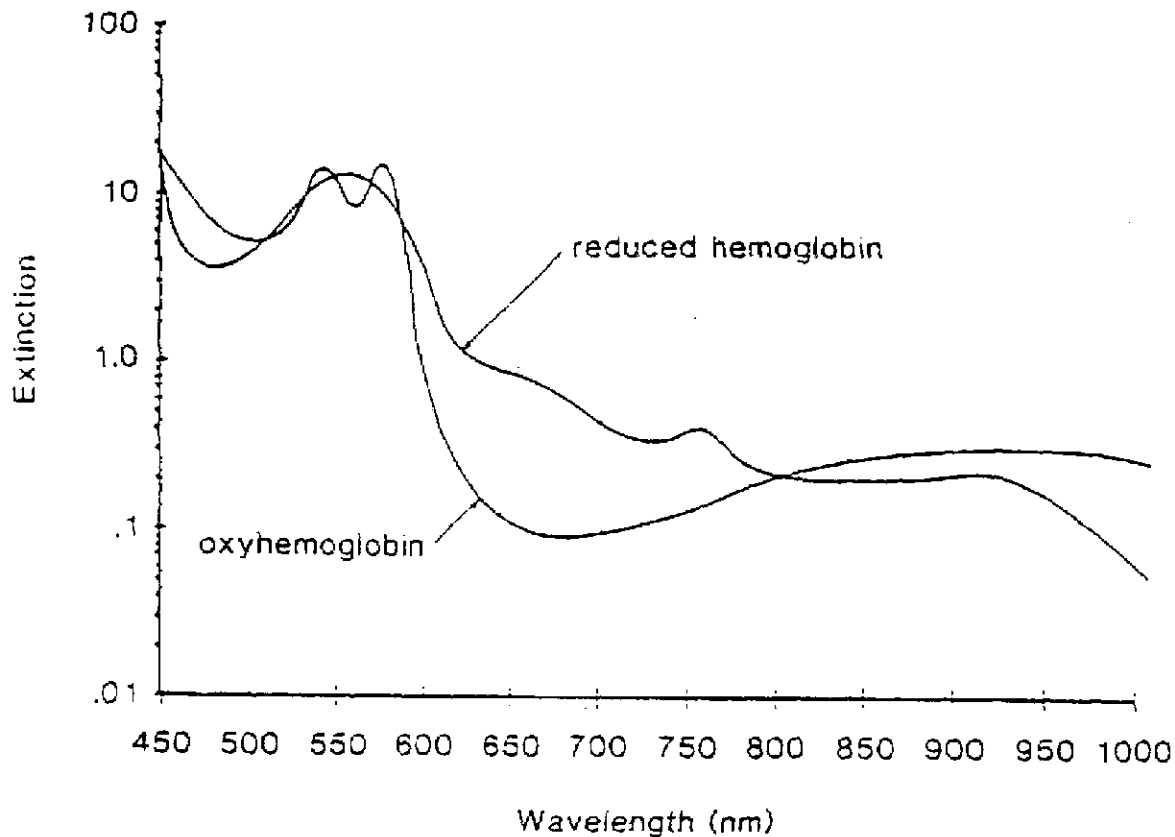
Figure 1 : Diagram showing absorption (extinction coefficient) versus wavelength for oxy-haemoglobin(HbO<sub>2</sub>) and deoxy-haemoglobin(Hb).

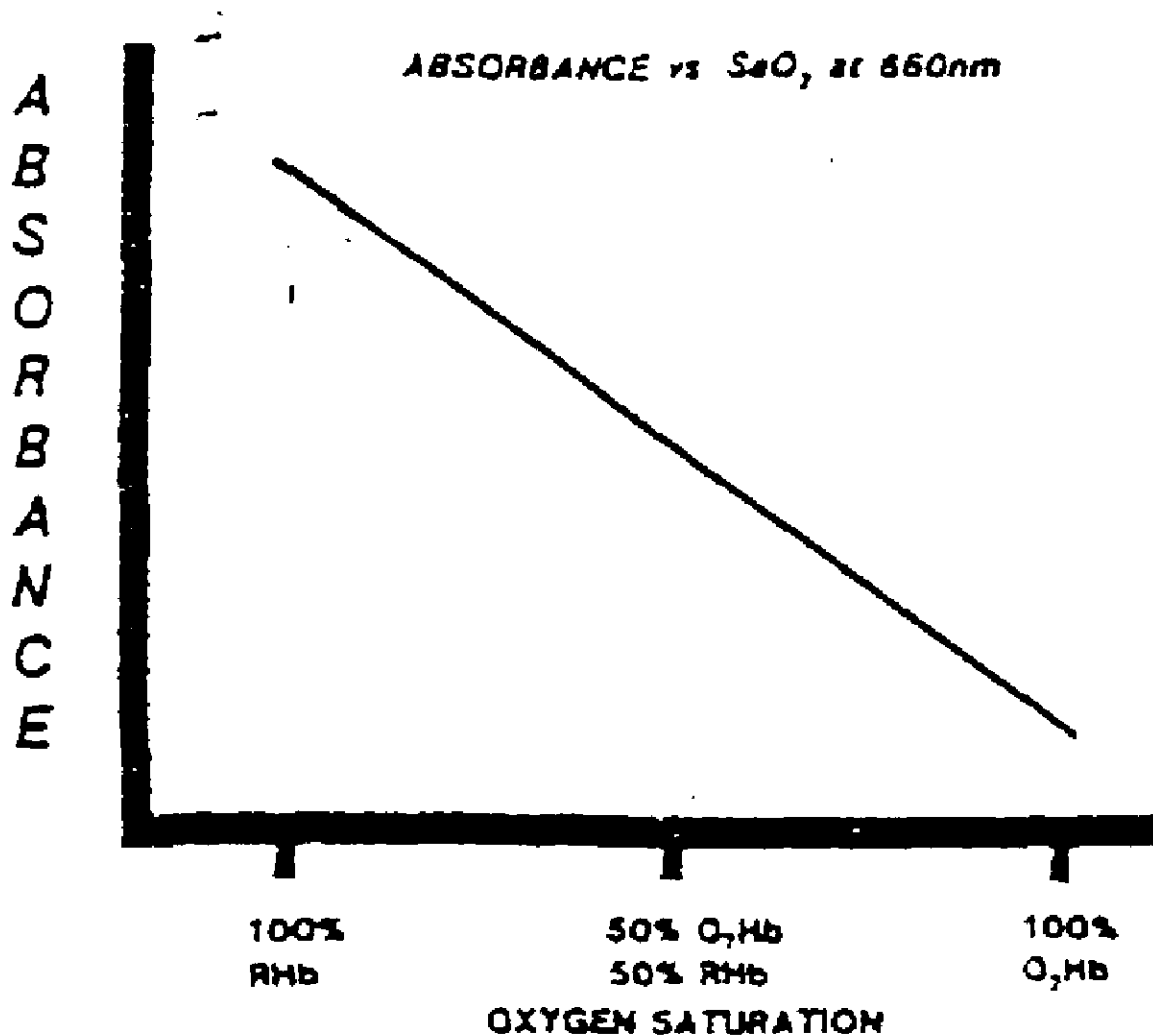
This is shown schematically in Figure 2 - as percentage saturation increases from left to right across the horizontal axis, absorption of red light at 660nm decreases. The relationship is linear throughout the entire range of 0% HbO<sub>2</sub>, 100% Hb to 100% HbO<sub>2</sub>, 0% Hb. The extent of negative gradient of the line is a indication of the difference in absorption levels for the two types of haemoglobin at this wavelength.

Figure 2 : Absorption of red light at 660nm compared to the level of blood saturation.

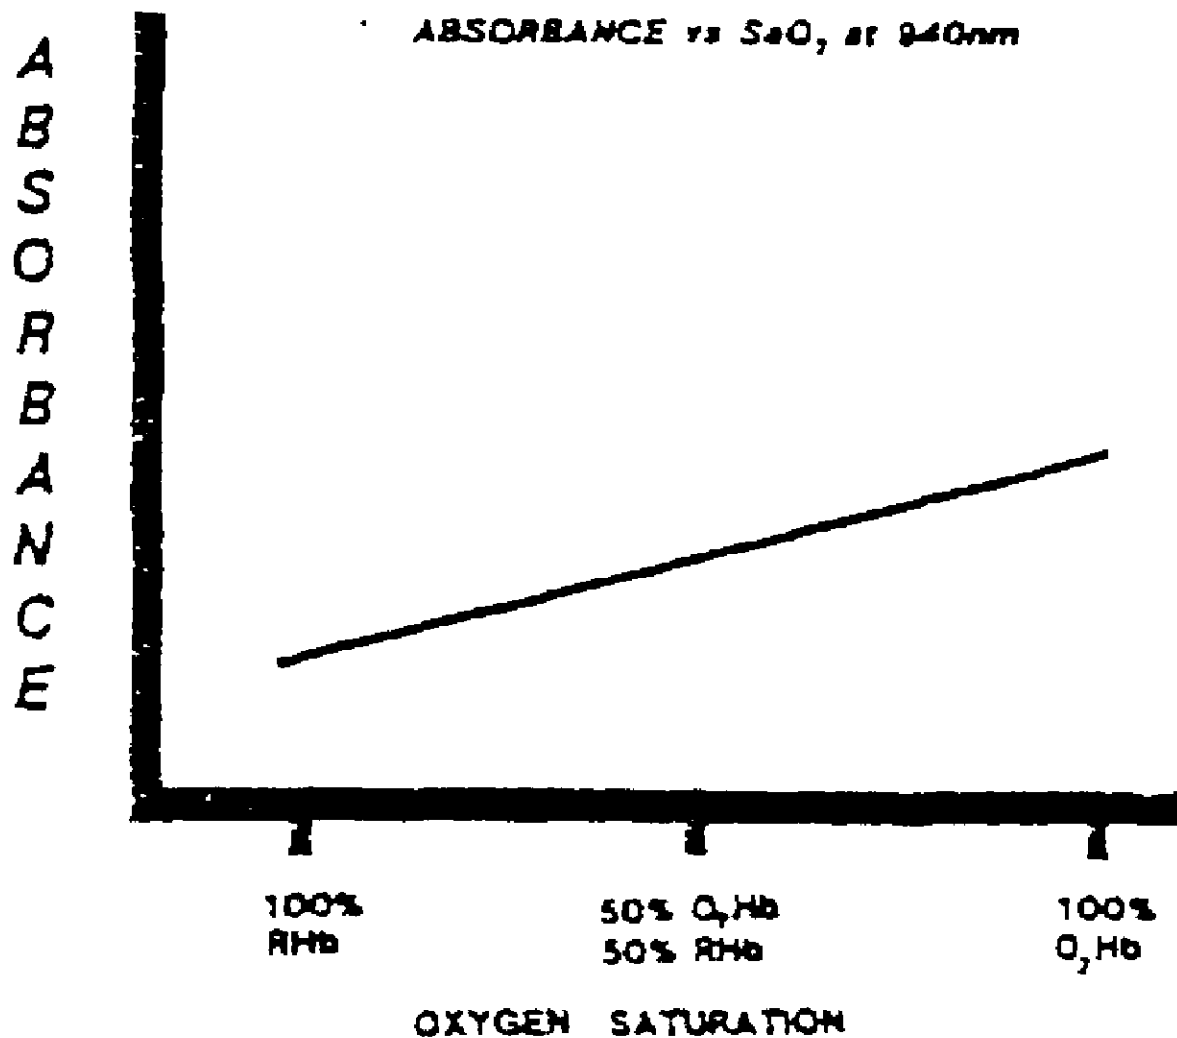
Figure 3 : Absorption of red light at 930nm compared to the level of blood saturation.

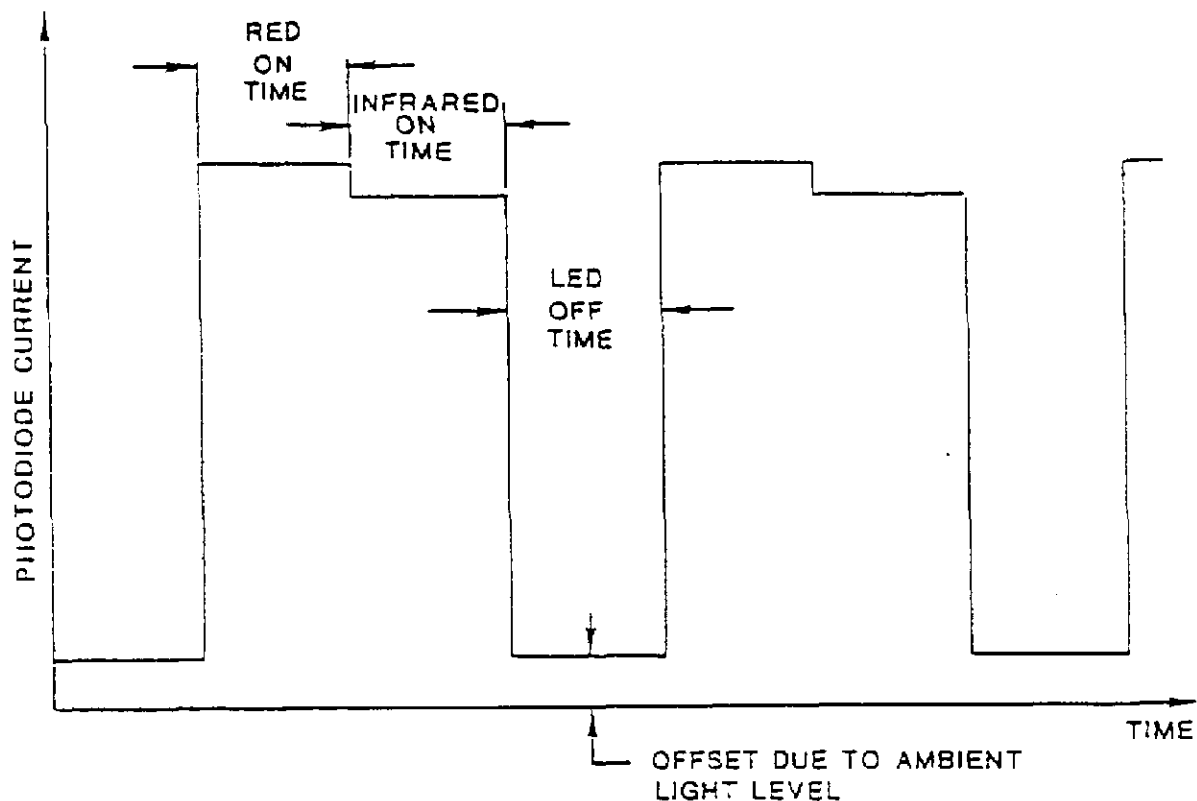
Figure 4 : Diagram showing the sequence of pulses of red and near infrared and measurement of ambient light (neither red nor infrared on).

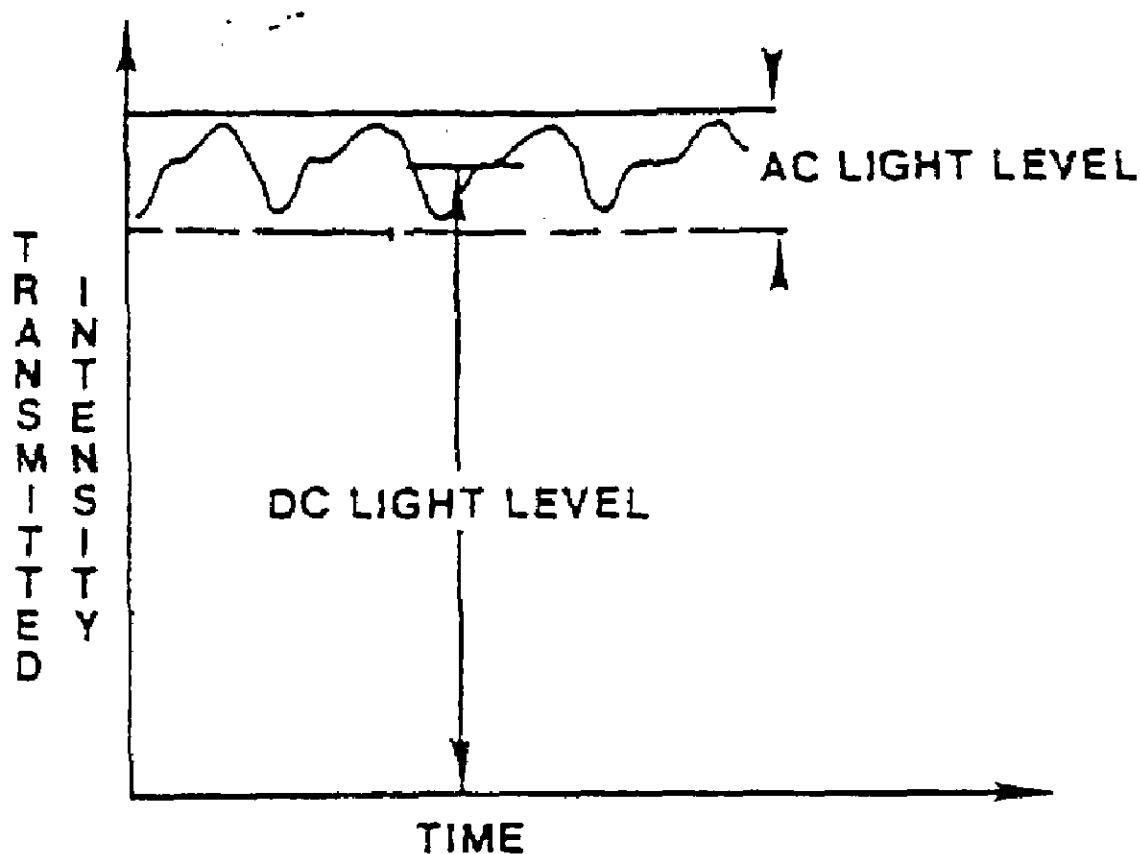
Figure 5 : Schematic representation of AC signal and DC level produced by transmission of the given wavelength of light through living tissue.

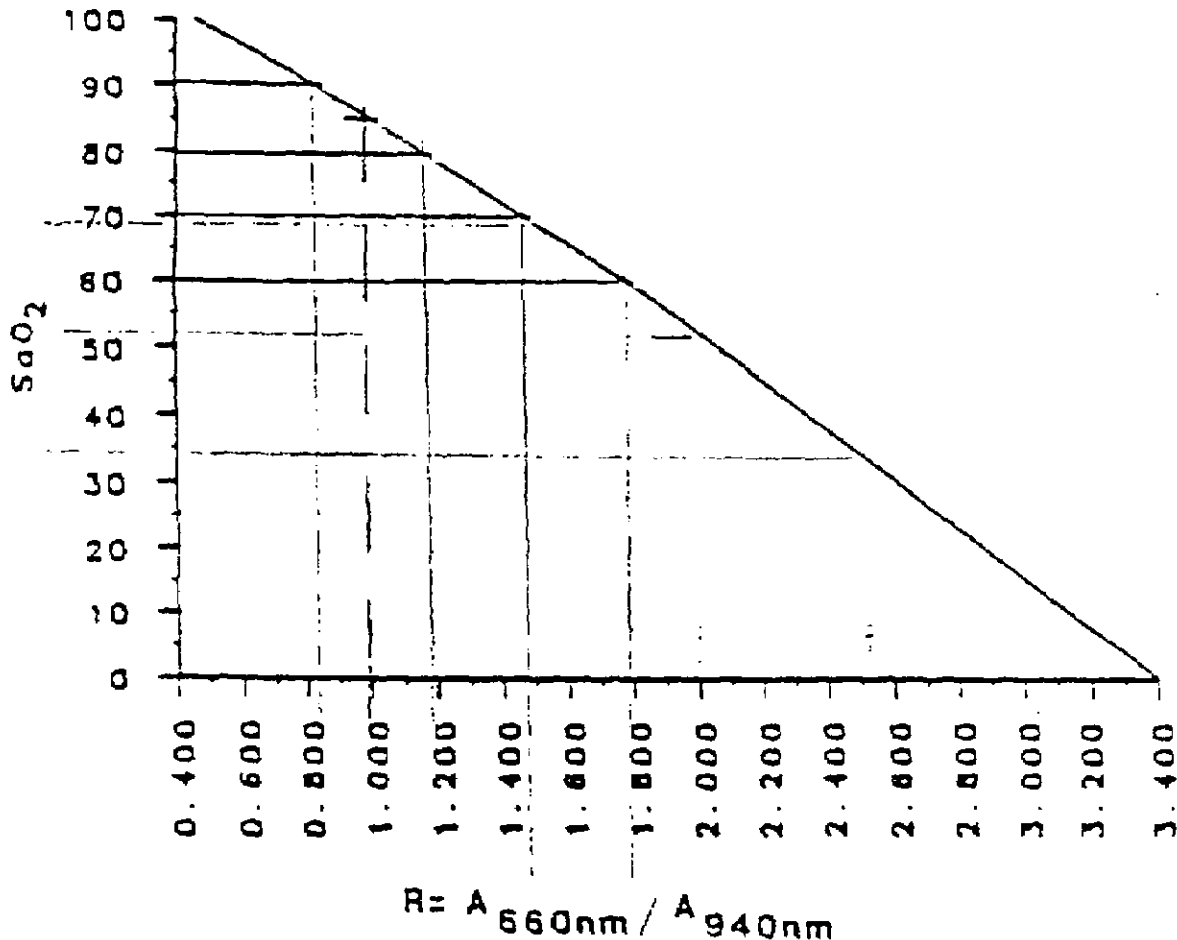
Figure 6 : Diagram showing the relationship between R ratio derived and displayed spO<sub>2</sub>.

In many pulse oximeters, when the calculation for R ratio equals 1.00, the value of SpO<sub>2</sub> is 85%. R ratio values of less than 1.00 indicate above saturations above 85% and R ratio values greater than 1.00 indicate saturations below 85%. These can be seen in Figure 6.
