**Summary of investigation into P867RA underread on 3800 oximeter.**

**Report : Underread of P867RA on Ohmeda 3700e oximeter.**

# Underread of P867RA probes on Ohmeda 3800 pulse oximeter : 02-03-01 : SW.

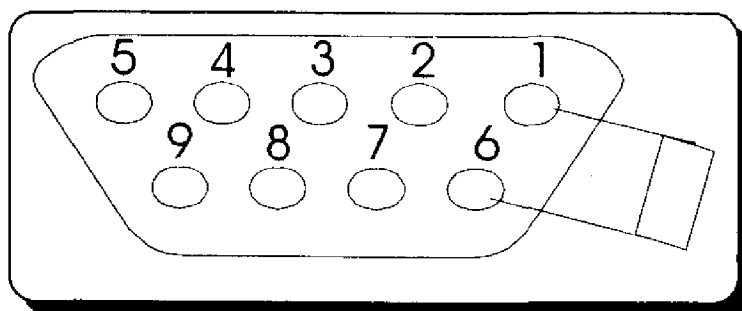
The P856RA has inner and main screen connected to Pin 7. This is also true for Epic

The Original Nellcor has the inner screen separately connected to Pin 6. The inner screen is not connected at the finger clip end.

6. We are re-wiring a DB9 ( Amp) splitting the screens and will test it on a Merlin.
7. We need to establish very quickly whether or not we have a wiring general problem or a batch problem.
