**Microstim Assessment: Production Batch 1 – received 20<sup>th</sup> July 2016**

Microstim Assessment: Batch 1  
Date: 31<sup>st</sup> August 2016  
Updated: 31<sup>st</sup> August 2016

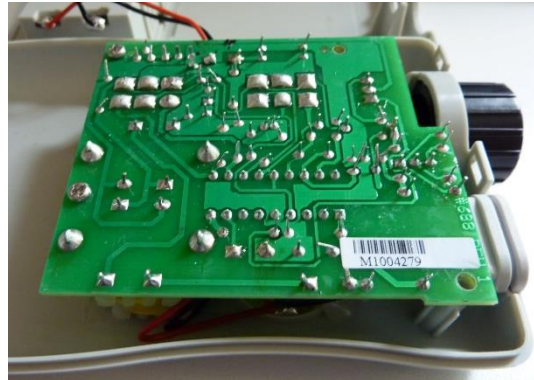
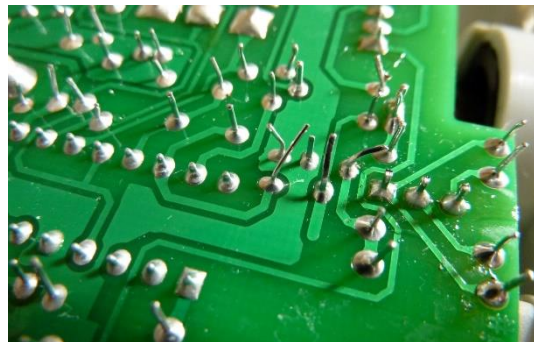
- The length of the component leg, that protruded from the underside of the PCB, was excessive. This could cause shorting if the component legs, when bent, touched other contacts. It became necessary to perform remedial work to rectify this issue.

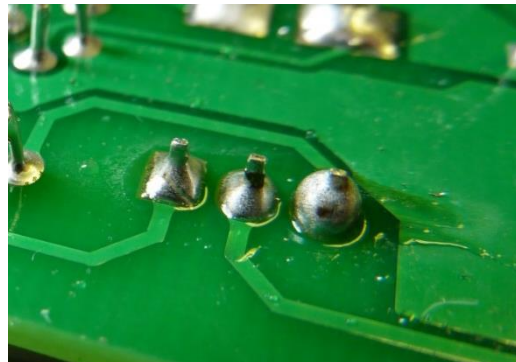
- In general, the soldering was of an acceptable standard. Some examples of 'less than ideal' soldering were seen.

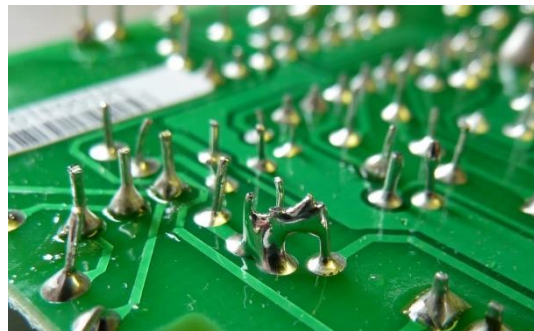
- There were also a small number of more serious solder faults, such as the solder bridge shown here. These faults are likely to be related to the excessive component leg length.
