**TEST REPORT R17VAN SENSORS,  
SN 798457 and 153743  
Michael Gonzalez  
11/20/2008**

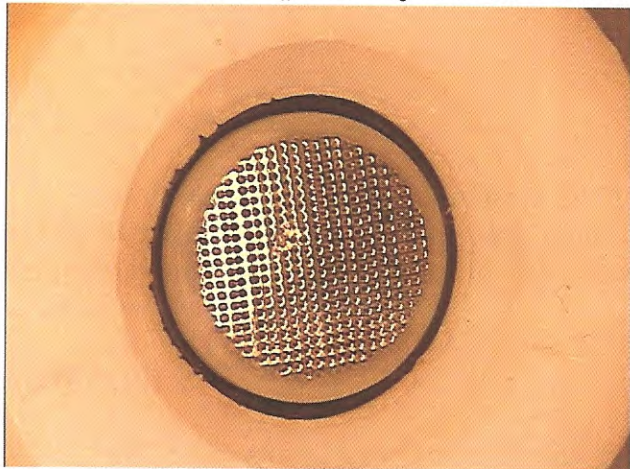
Sn 798457

**Sensing surface appearance (good – good seals, no defect, no leakage)**

Note: spot weld joint under the cathode can be seen but this is normal.

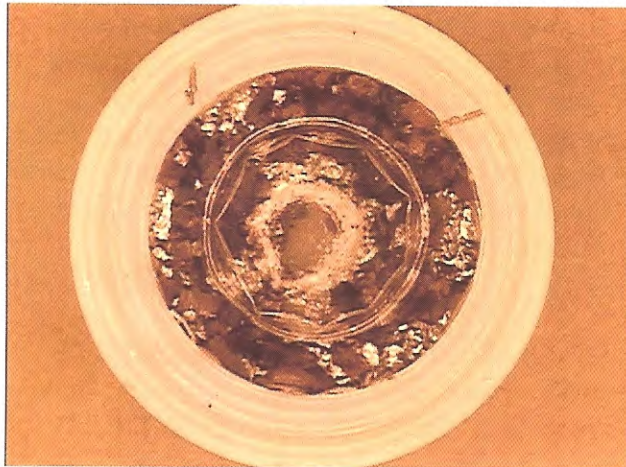
Sn 798457 (mfgd Nov '06)

**Anode appearance (good)**

Note: dark red lead oxide coloration is seen due to the age of each sensor.
