RE: Additional feedback of sensor gas leakage

From: Main Account <viamedinbox@gmail.com> **On Behalf Of** Steve Nixon
Sent: Wednesday, August 22, 2018 9:15 AM
To: Narasimhan, Vasu P <Vasu.Narasimhan@Teledyne.com>
Cc: Kothari, Kunal <Kunal.Kothari@Teledyne.com>
Subject: Additional feedback of sensor gas leakage

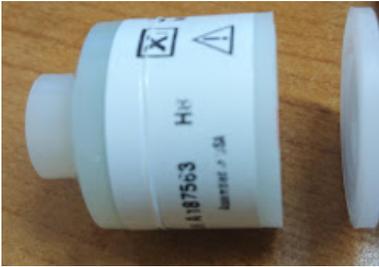
R-22AHJR pic 1.JPG
313K

With a flow of oxygen at 4 hPa above atmospheric pressure, 4 out of 90 sensors failed. At a pressure of 40 hPa above atmospheric 5 sensors failed.

The Arbor press results in reducing the gap between the casing parts by circa 0.40 - 0.45 mm

Pic 1 shows that if the sensor is pressed (pushed together again) the effect is seen in the creasing of the label. The inner sensor moves forward to the end cap by circa 0.40 - 0.45 mm.

So, the use of your Arbor press is the solution, perhaps just the applied pressure needs reviewing.
