**Fwd: Re: Exploded O2 cell**

Emne: Exploded O2 cell

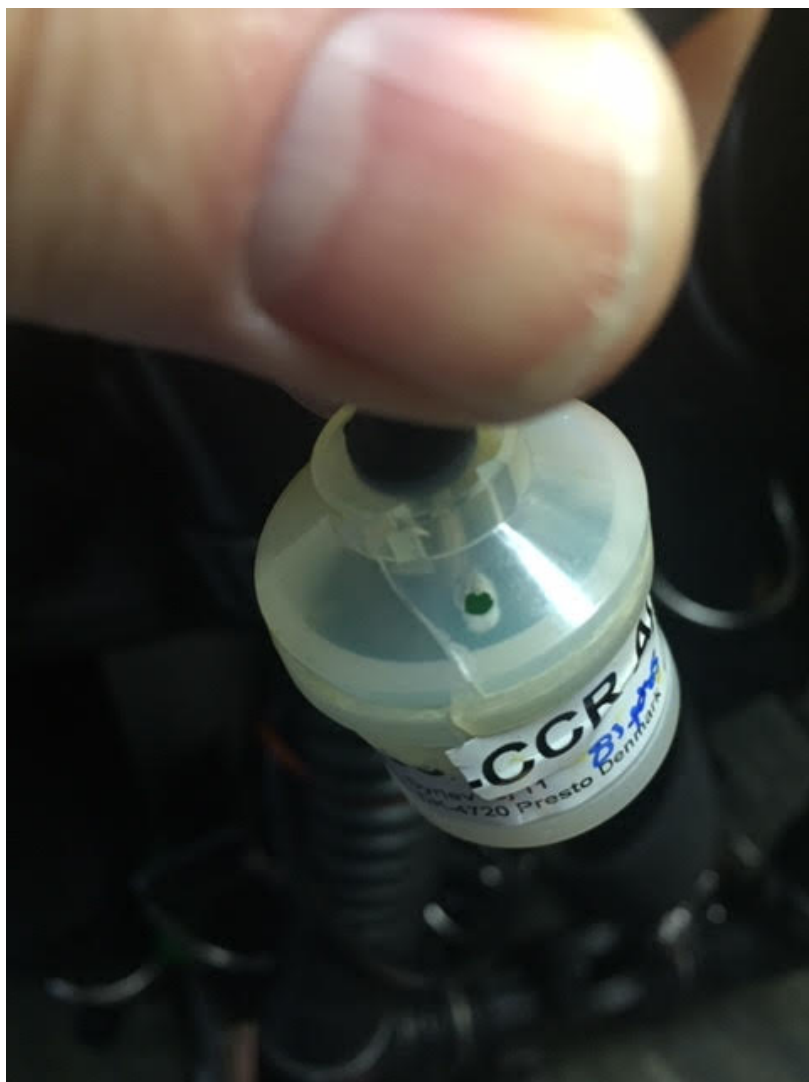
There is a pressure equalization hole on the rear cap.

Did investigate rear hole and this one is completely clear see pict below.

We need this sensor back for evaluation, can you please return it using returns number: **SRS66842**
