MHRA Ref 2012/001/030/031/001 (& 2012/001/018/401/002)

Medical device adverse incident report from Nottingham University Hospitals Trust – City Campus
(their ref: 34655 NUHWEB18288 17/01/2012.

B. Investigation of the cause of the Incident

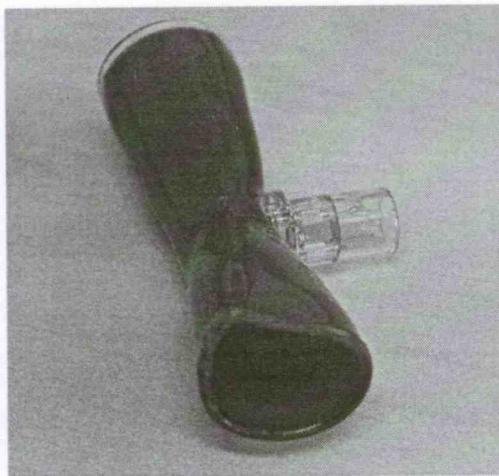
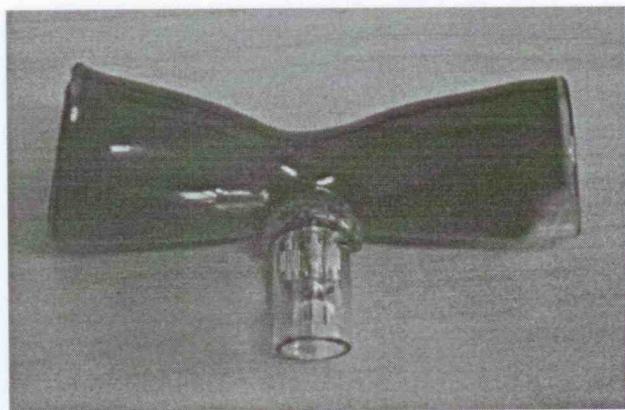
Upon initial inspection the unused sensors do not indicate any abnormalities. The sensor that caught fire and returned for investigation does indeed exhibit fire damage - as can be clearly seen by the pictures below.

We will conduct further tests. However, initial thoughts are that perhaps a contaminant fuel source was inadvertently introduced, say if the sensor was used immediately after being disinfected. It also has to be considered whether the breathing system (patient circuit or ventilator parts) was disinfected immediately prior to use. In the Draeger instructions for use relating to the ventilator, there is a warning about possible fire hazard after flow sensor disinfection... In addition, included in with each box of sensors - the instructions for use clearly states that there is a possible fire risk, if medicaments or other substances based on combustible solvents, such as alcohol are introduced into the patient systems.

As far as we are aware there isn't anything in regard to the sensor manufacturing materials that could cause this incident.

If the sensors are used in line with the instructions for use (copy attached), then there should not be a reoccurrence; whether Viamed sensors are used or whether Draeger sensors are used
