Investigation into Ceratherm Radiant Warmer Failure

Customer: North Middlesex University Hospital (a/c 00003070)
Instrument p/n: 0310302 – Ceratherm 600-3 wall-mounted radiant warmer
Serial Number: 304-3-0813
Date supplied: 05/09/13

Initial incident reported by Kamal Pacitti, Medical Equipment Management Services / EBME Department, 19/1/15

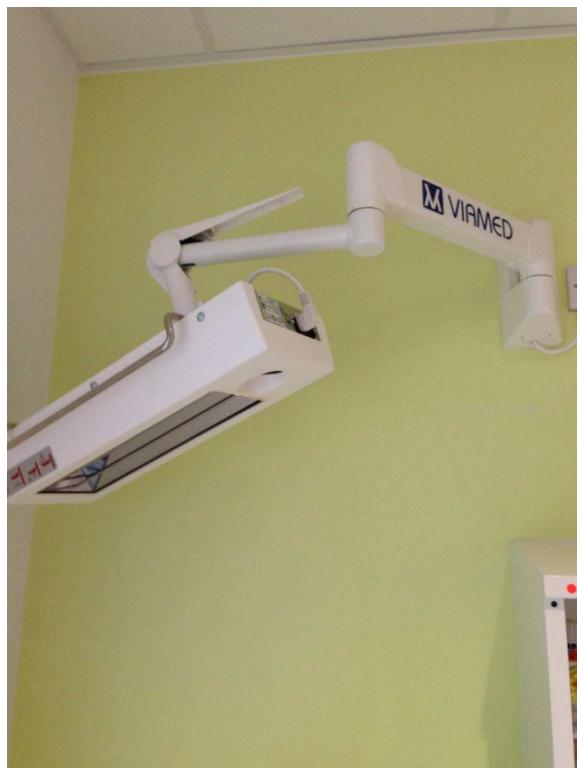
Fig. 1

Reported failure: the head unit of a Ceratherm 600-3 radiant warmer is hanging down at an angle and the plastic casing on the head unit is showing signs of burn marks. The following images were sent to Viamed to illustrate the issue.

In fig.1, it can be seen that a plastic hinge cover that is normally flat to the arm has risen in the region of 20-30 degrees. This cover serves a cosmetic function only and is secured in place by a small plastic tab, as can be seen in fig.3 below (the tab is located above the letter C in this image).

The scorch marks and deformation of the head unit's plastic casing is only evident at the end of the casing that was left in a raised position following the mechanical failure.

During normal operation in a horizontal place, the casing will not suffer from heat damage, regardless of the length of time for which the device is operated. Viamed surmises that the action of operating the radiant warmer on an inclined place has created an upward convection of hot air towards the raised end of the warmer, subjecting the casing at that end to excessive heat. This is outside the normal operating parameters of the device.

- 1) Immediate inspection of the arm and securing mechanism to determine whether the mounting arm requires return to Viamed.

- 2) Function and safety testing of the radiant warmer head unit to ascertain whether the device is operating within specification: if it is not, then it should be returned to Viamed for investigation. If the device is operating within specification, the damaged casing can be repaired in-house using the following replacement part available from Viamed:

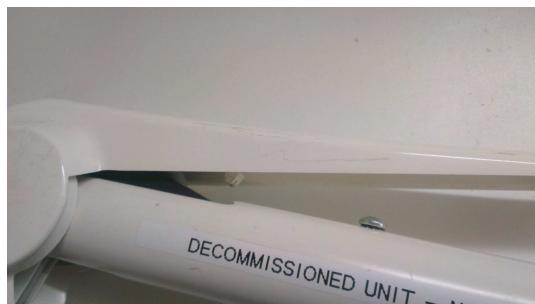
Fig. 3

Fig.3 and fig.4 also show a Philips-head screw towards the middle of the mounting arm on the top: this screw is designed to lock the final section of the mounting arm into the vertical position at right angles to the horizontal section.

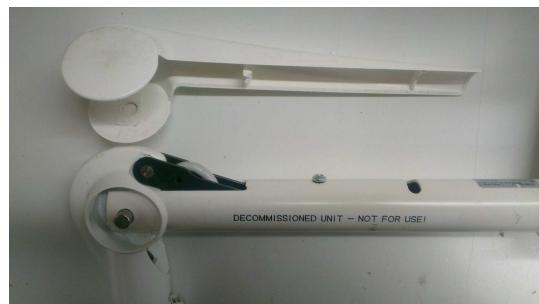
Fig. 4

The hinge cover can be completely removed, as shown in fig.4, by pulling apart the circular sections of the cover. This reveals a sturdy hinge mechanism, which is designed to rotate in other intended applications for this mounting arm, hence there is no risk of the head unit detaching through having rotated to this angle.

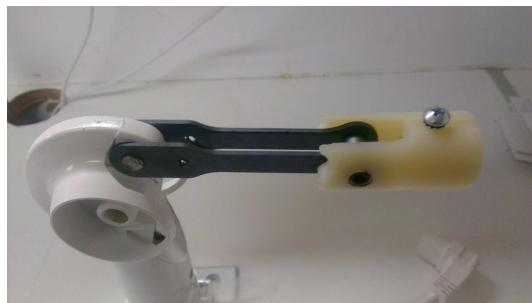
Fig. 5

The locking screw passes through a non-threaded hole in the top of the mounting arm and screws into a plastic cylinder (fig.5) via a self-tapping method (fig.6). Removal of this screw allows the plastic cylinder to travel along the inside of the tubular mounting arm, providing some resistance and allowing the hinge to rotate.

Analysis of the securing mechanism components may provide some indication of the cause of the failure: if the securing screw has been sheared off or pulled out of the plastic cylinder with sufficient force to damage the plastic cylinder, this would indicate that excessive load was applied.

If the securing mechanism has suffered a failure involving physical damage to the component parts, for example if the screw head has sheared off or if the plastic cylinder has become damaged or deformed, then Viamed would recommend the return of the mounting arm for repair.
