Investigation into Ceratherm Radiant Warmer Failure

Customer: North Middlesex University Hospital (a/c 00003070)
Instrument p/n: 0310302 – Ceratherm 600-3 wall-mounted radiant warmer
Serial Number: 304-3-0813
Date supplied: 05/09/13

Initial incident reported by Kamal Pacitti, Medical Equipment Management Services / EBME Department, 19/1/15

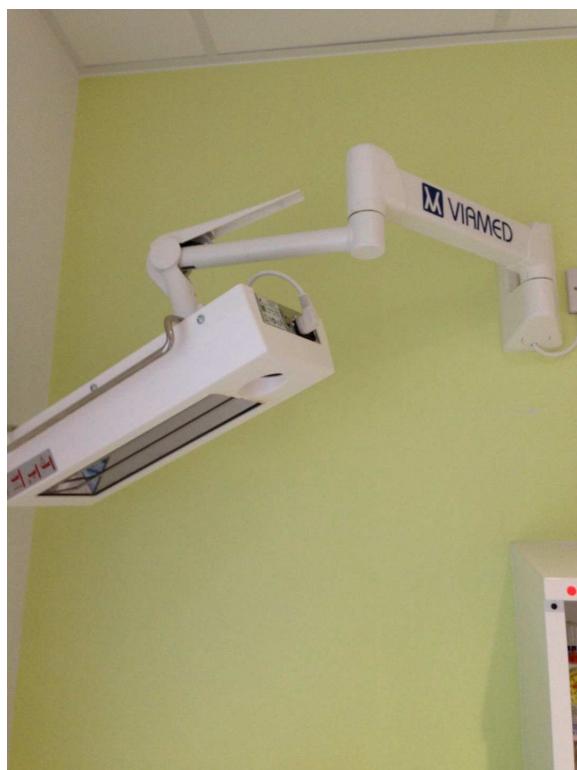
Fig. 1

Reported failure: the head unit of a Ceratherm 600-3 radiant warmer is hanging down at an angle and the plastic casing on the head unit is showing signs of burn marks. The following images were sent to Viamed to illustrate the issue.

In fig.1, it can be seen that a plastic hinge cover that is normally flat to the arm has risen in the region of 20-30 degrees. This cover serves a cosmetic function only and is secured in place by a small plastic tab, as can be seen in fig.3 below (the tab is located above the letter C in this image).

Viamed advised NMUH that the radiant warmer be immediately taken out of service if it has not been already, whilst Viamed investigate in more detail and assess the risk.

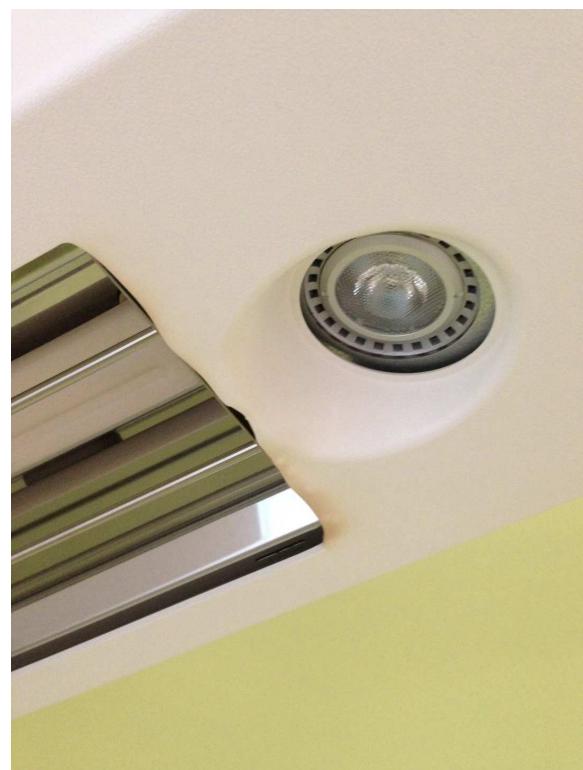
Fig. 2

The scorch marks and deformation of the head unit's plastic casing is only evident at the end of the casing that was left in a raised position following the mechanical failure.

During normal operation in a horizontal place, the casing will not suffer from heat damage, regardless of the length of time for which the device is operated. Viamed surmises that the action of operating the radiant warmer on an inclined place has created an upward convection of hot air towards the raised end of the warmer, subjecting the casing at that end to excessive heat. This is outside the normal operating parameters of the device.

- 2) Function and safety testing of the radiant warmer head unit to ascertain whether the device is operating within specification: if it is not, then it should be returned to Viamed for investigation. If the device is operating within specification, the damaged casing can be repaired in-house using the following replacement part available from Viamed:

P/n 0330001 – Ceratherm 600-3 casing @ £98.00+VAT

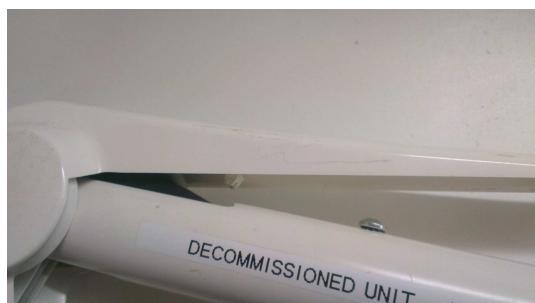
Fig. 3

Fig.3 and fig.4 also show a Philips-head screw towards the middle of the mounting arm on the top: this screw is designed to lock the final section of the mounting arm into the vertical position at right angles to the horizontal section.

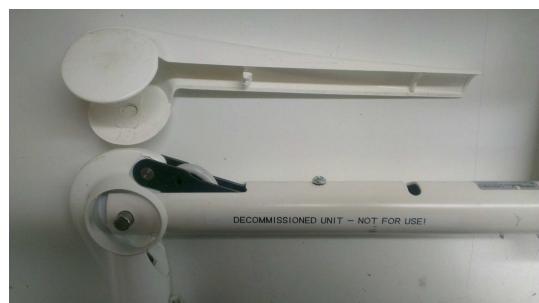
Fig. 4

The hinge cover can be completely removed, as shown in fig.4, by pulling apart the circular sections of the cover. This reveals a sturdy hinge mechanism, which is designed to rotate in other intended applications for this mounting arm, hence there is no risk of the head unit detaching through having rotated to this angle.

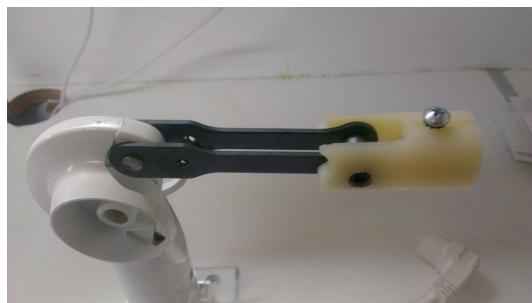
Fig. 5

The locking screw passes through a non-threaded hole in the top of the mounting arm and screws into a plastic cylinder (fig.5) via a self-tapping method (fig.6). Removal of this screw allows the plastic cylinder to travel along the inside of the tubular mounting arm, providing some resistance and allowing the hinge to rotate.

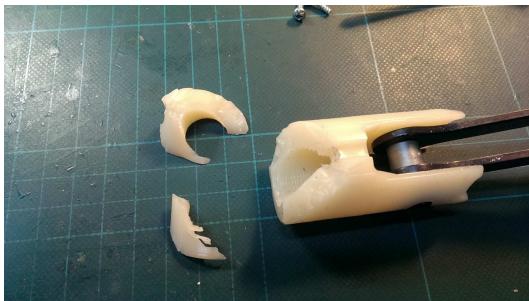
Fig. 7

The mounting arm was returned to Viamed for inspection. The following images illustrate that the plastic cylinder inside the securing mechanism has broken into 3 separate pieces (fig.7).

The plastic cylinder has broken away at the point where the screw enters it and appears to have been caused by a lateral force in a direction that is consistent with the effect of pulling the head unit downwards from the front.

Based on the evidence of this inspection, it is Viamed's conclusion that the radiant warmer head unit was subject to considerable downward force, exerting a loading in excess of the design specification, which resulted in mechanical failure.

Viamed concludes that the failure of the mounting arm was caused by either misuse or accidental damage and is not representative of an in-service failure that could affect other systems under normal operating conditions. As such, beyond the repair of the mounting arm and documenting of this incident, no further action is deemed necessary.

A quotation will be provided to North Middlesex University Hospital for the repair of the arm with a request for permission to proceed.

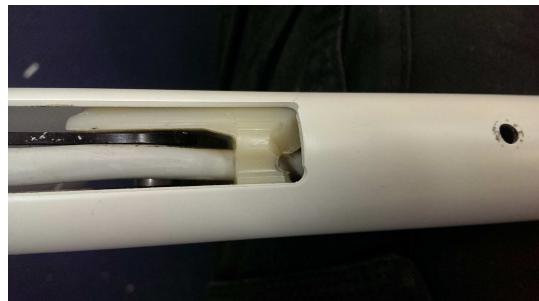
Fig. 8

It is apparent from inspecting the arm that the retaining screw was in place originally, as can be seen from the compression marks around the hole that the screw passes through, which are created by the lock washer (fig.8).
