Temperature Sensor Failure Report

Stock reference: 0212030

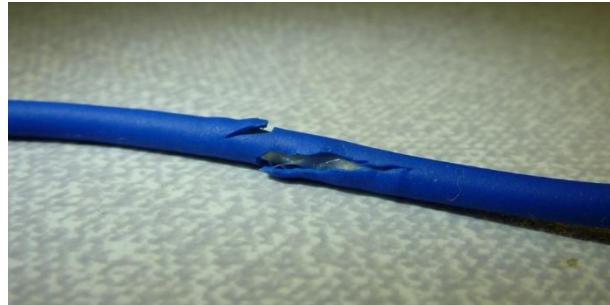
SN: V150110404 – The temperature sensor has been tested. The sensor is working as expected. The outer cable has split, exposing the nylon braiding and inner wiring. This fault is, most likely, due to accidental damage.

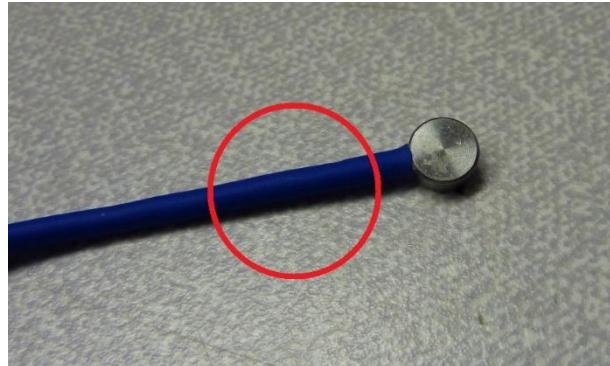
SN: V150110406 – The temperature sensor has been tested. The sensor is open circuit. The cable at the sensor head feels empty. It is likely that the sensor head has come away from the wiring.

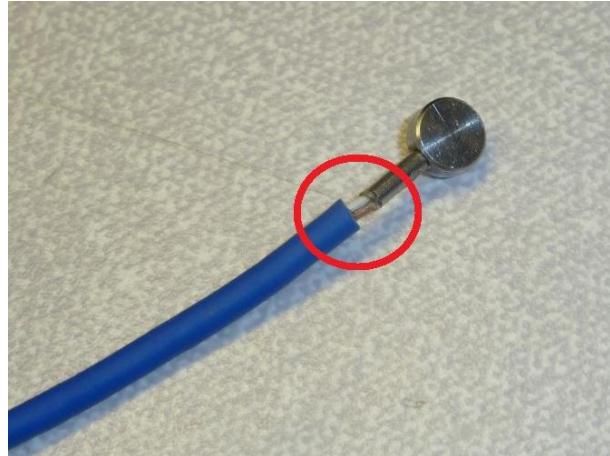
SN: V150110407 – The temperature sensor has been tested. The sensor is open circuit. The sensor head has come away from the cable, but remains attached by the braiding and internal wiring.

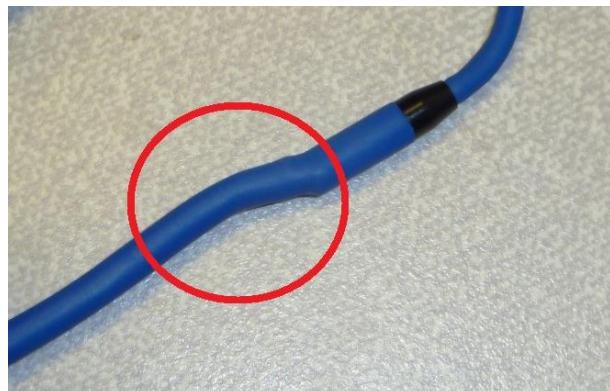
There is a kink in the cable at the cable joint.

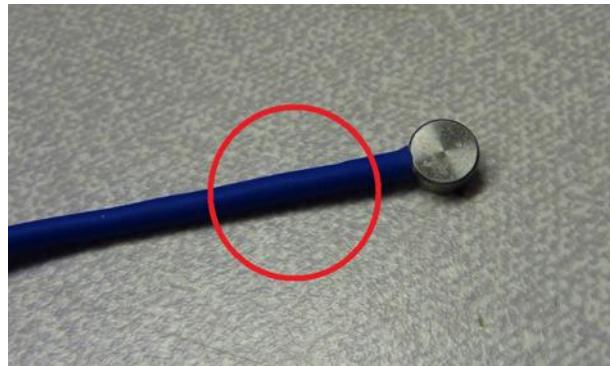
SN: V150110480 – The temperature sensor has been tested. The sensor is open circuit. The cable at the sensor head feels empty. It is likely that the sensor head has come away from the wiring.

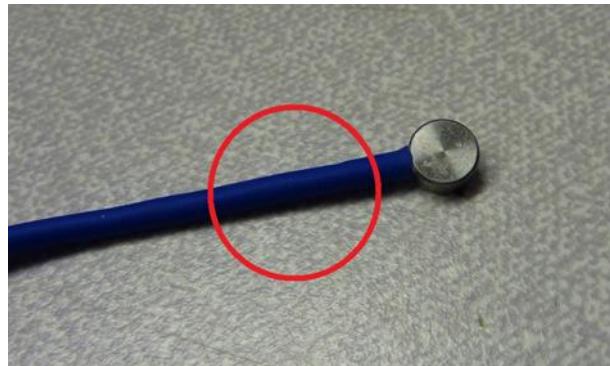
SN: V150110481 – The temperature sensor has been tested. The sensor is open circuit. The cable at the sensor head feels empty. It is likely that the sensor head has come away from the wiring.

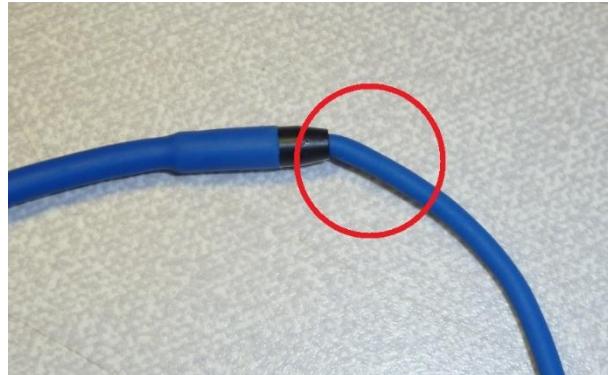
SN: V140110377 – The temperature sensor has been tested. The sensor is open circuit. The cable has an intermittent break at the cable joint.

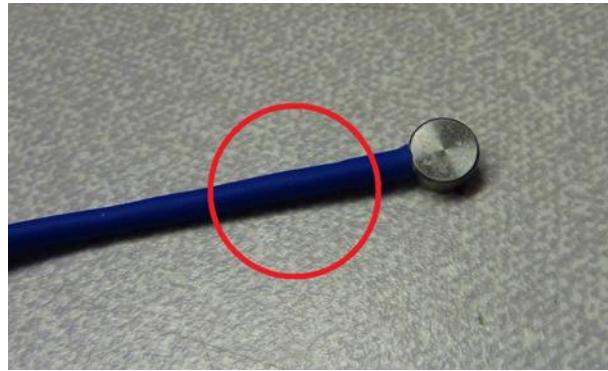
SN: V150110397 – The temperature sensor has been tested. The sensor is open circuit. The cable at the sensor head feels empty. It is likely that the sensor head has come away from the wiring.

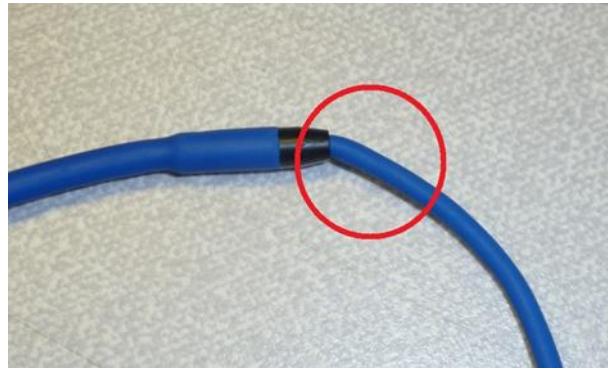
SN: V150110398 – The temperature sensor has been tested. The sensor is open circuit. The cable has an intermittent break at the cable joint.
