COMPONENT SAFETY ASSESSMENT: MECHANICAL ROBUSTNESS OF TELEDYNE R22 OXYGEN SENSORS

DOCUMENT NUMBER:
[Filename] DV_O2_sensor_Teledyne_R22D_071019.doc

DATE UPDATED: 19th October 2007

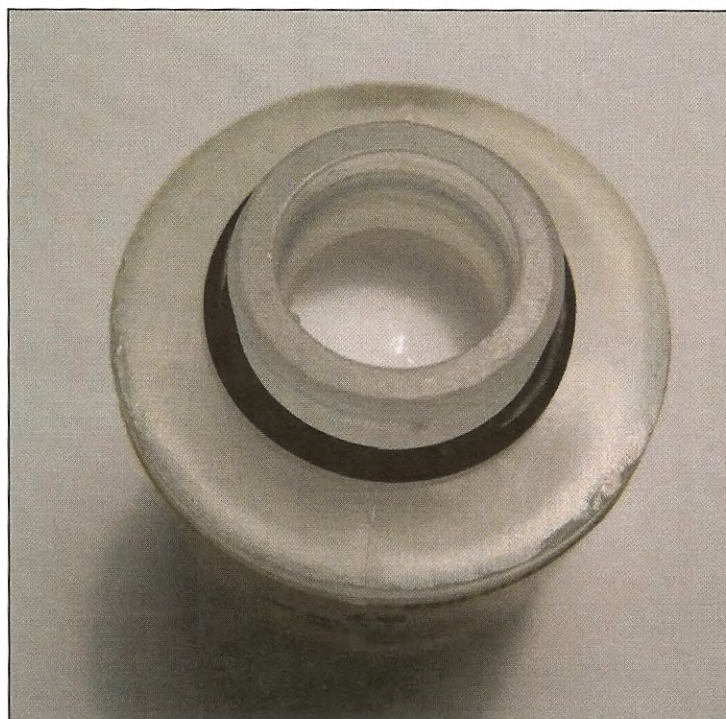
Fig 3-3: Electrolyte drops on the sensor membrane

After the third 3m drop, a knocking noise was noticed when the sensor was shaken. After the sixth 3m drop, small drops of electrolyte were noticed on the sensor's membrane (Fig 3-3). After the eighth 3m drop, a small dent was noticed near the sensor connector (Fig 3-4).

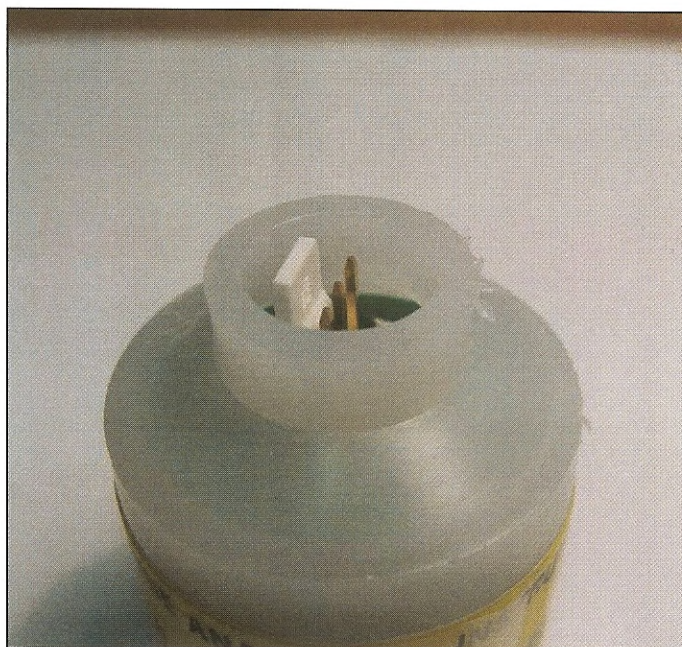
Fig 3-4: There is a small dent near the connector hole of the sensor

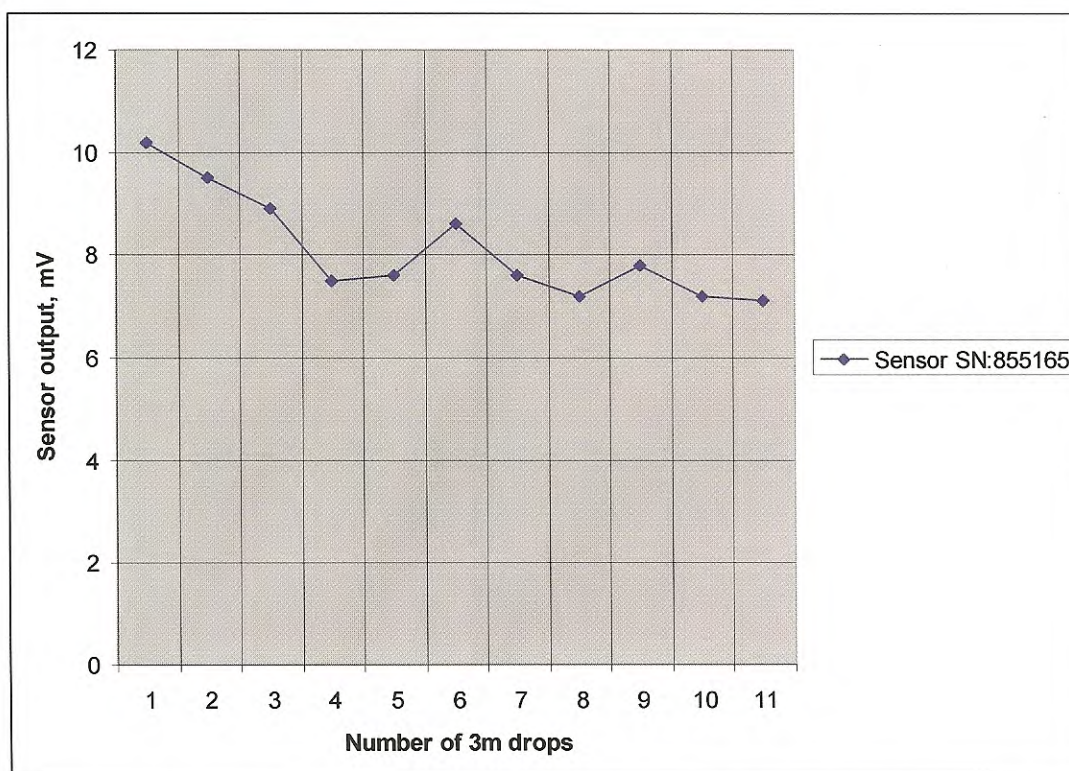
Fig 3-5: Fresh B7 sensor output during 3m drop tests.

During the 3m drops on to a hardwood board with a thick metal plate beneath, an initial decrease in the output signal was registered. The total decrease was 3.1mV or 31% of the initial value. There was no audible noise when the sensor was shaken, indicating there is nothing loose inside the sensor.

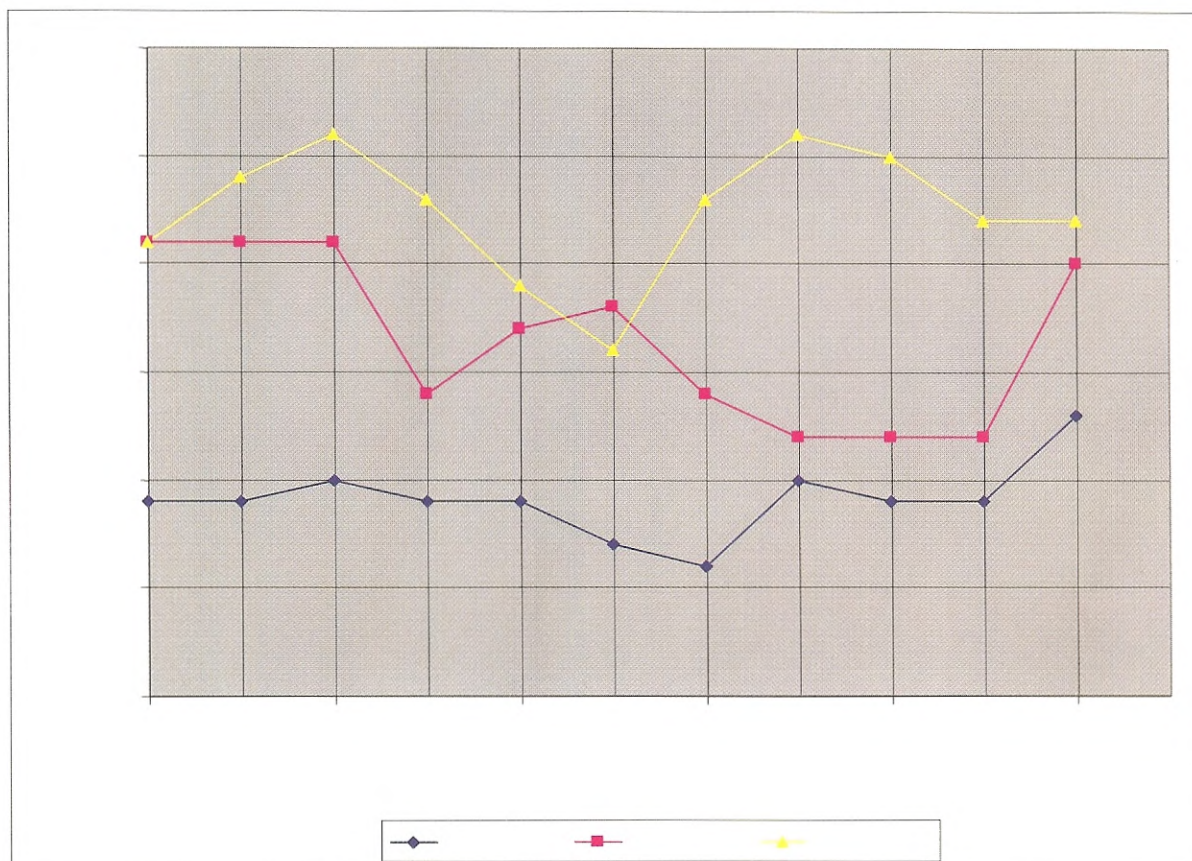
Fig 4-1-: F7 sensor output during 1.5m drop tests.

4.2. 1.5m drop tests revealed that the output signals of the F7 sensor were more stable than those of the B7 sensors. Variations in the sensors' output were caused by random noise from temperature, pressure, electrical noise. A slight knocking sound when the sensor was shaken lightly was noticed after the first drop for Sample 3, after the fifth drop for Sample 2 and after the tenth drop for Sample 1 (the corresponding cells are marked in light blue in Hard Drop test from 1.5m and 3m with sensors from batch F7

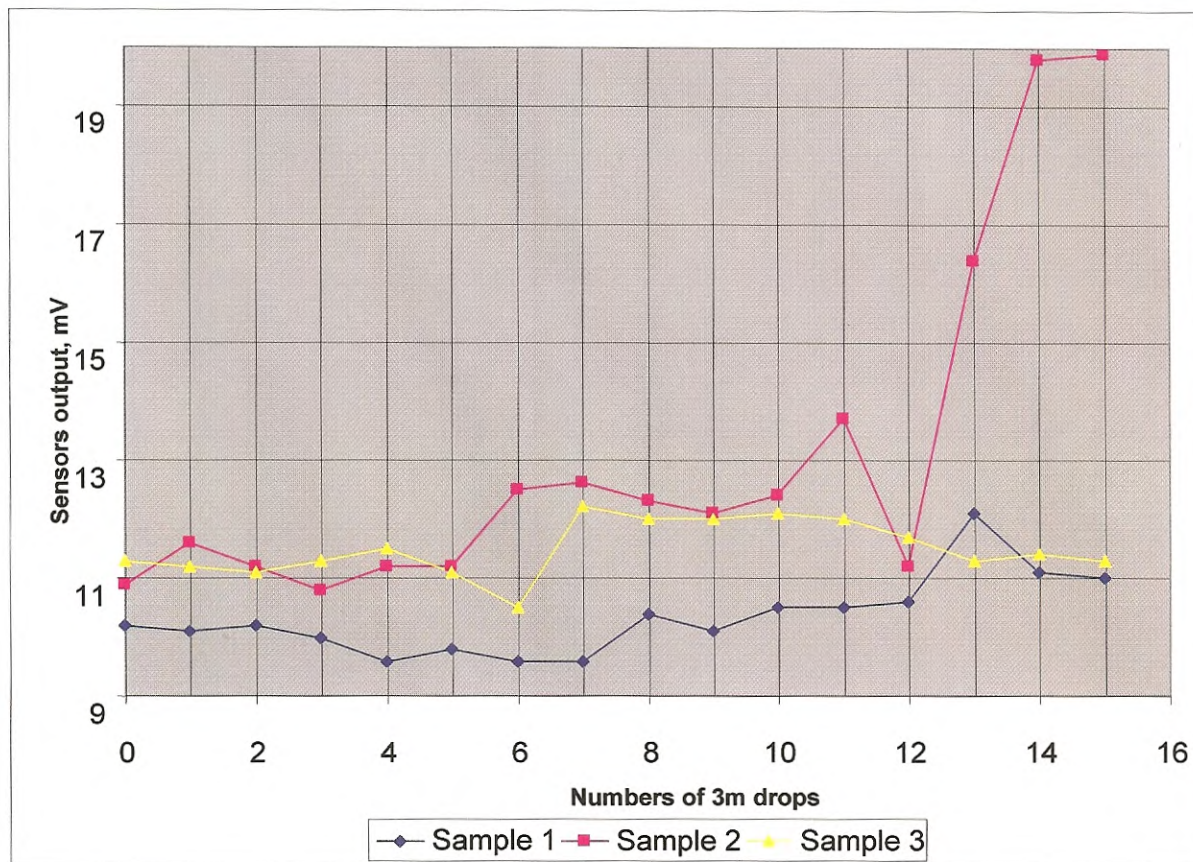
**Fig 4-2: F7 sensor output during 3m drop tests.**

The Batch F7 sensors were dropped 5 times on to a hardwood surface from a height of 3m. The wooden board was then laid on a thick metal plate and the test was continued (see the bold font results in

Table 5). After the sixth drop, a 'hammering' noise was heard from Sample 1 when it was held by its connector side and shaken. After the tenth drop, loud 'knocking' sounds were

The sensor outputs were more influenced by the 3m hard drops on to the wooden board when it had the metal plate below it than without the metal plate. The output of Sample 2 changed by about 83% and there was electrolyte leakage. After two days, its output stabilized at 20mV with some noise variations.

The output of Sample 3 had a small peak increase of 1.7mV and then showed a decreasing tendency. After two days its output was 10mV, with some noise variations due to ambient pressure, humidity and temperature.

The output of Sample 1 showed an increasing tendency. The change in its output was about 8%. After two days its output was 12mV, with some noise variations.
