Final Specification for the resuscitation cabinet

Whilst the sample cabinet that was delivered to Viamed meets most of the requirement, there are a few issues that need addressing for the full production units.

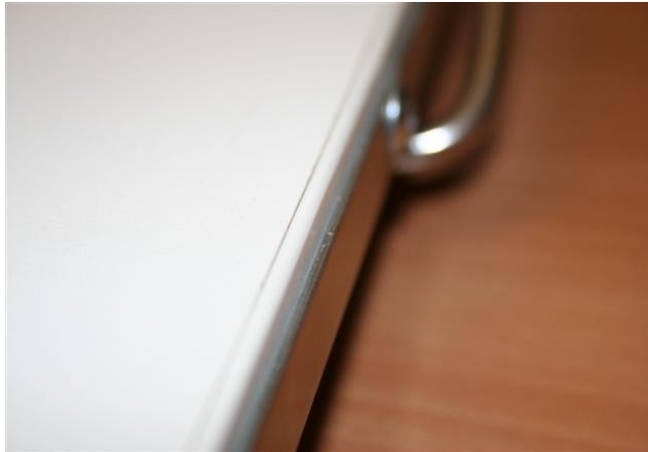
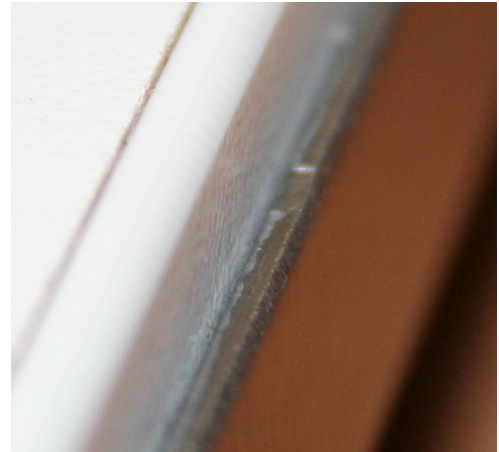
fig.1

On the sample that we received, some of the edges on the door-mounted part of the restraint exhibited some sharp edges, which needs addressing on the production units (fig.1).

The stainless steel door restraint needs finishing to remove sharp edges.

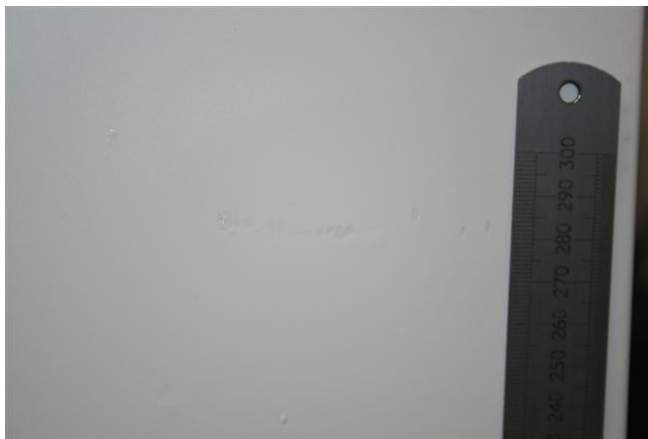
fig.2 (Paint blemishes running horizontally)

The sample unit may not be indicative of the overall quality of the finished production units, but it was noted that the paintwork of the sample unit suffered from blemishes (fig.2) and spot-welding marks (fig.3).

Welding marks and paint blemishes to be minimized.

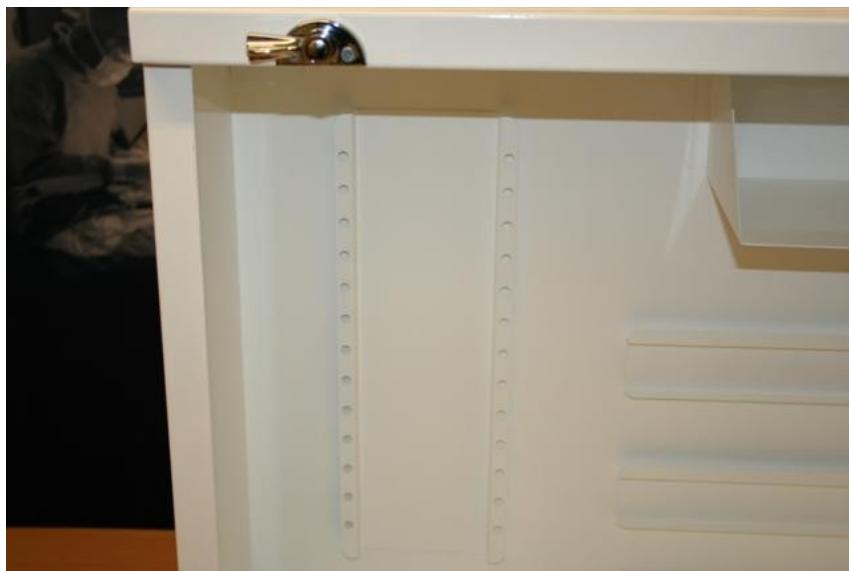
fig.4

The cabinet is supplied to Viamed without medirail, which Viamed will add. However, a recent attempt to mount additional equipment into the cabinet highlighted the fact that longer medirail are required.

Initial attempts to do this resulted in insufficient support to the right hand side of the medirail, which added unwelcome springiness to the rail.

The solution is to widen the spacing of the medirail mounting rack (fig.4), keeping the left hand side in the same position but moving the right hand side to the right, and add an additional single mounting rack for a third fixing point to the right of this.

Existing medirail mounting rack is to be re-sized.

An additional single mounting rack is to be added.

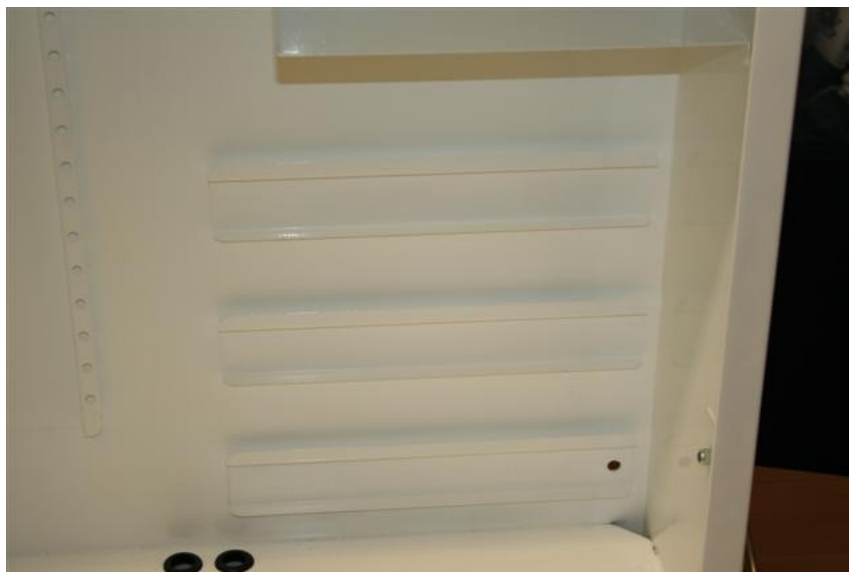
fig.5

The bin mounting rails (fig.5) would consequently need to be shorter, so that they do not sit behind the lower 2 sections of medirail.

Bin rails to be shortened.

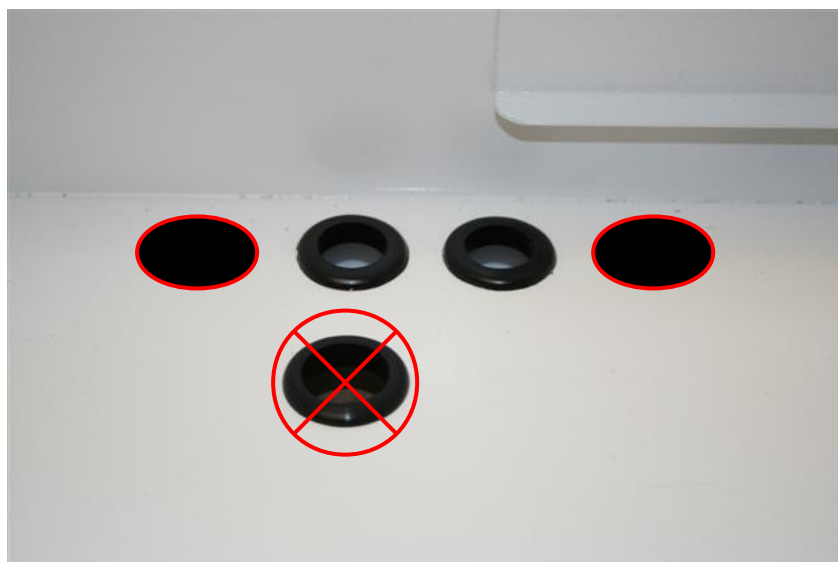
fig.6

The 3 gas access holes are situated with 2 near the back and 1 further forward as per the original design.

It has been decided that a further is to be hole added for future expandability and that these 4 holes should be in line, aligned with the 2 existing holes at the back. (fig.6)

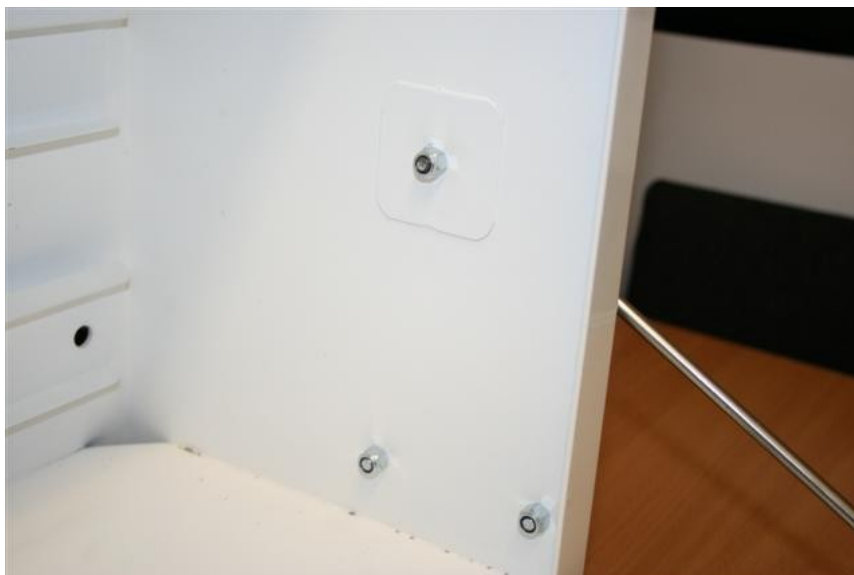
fig.7

The fixing bolts are exposed and ideally need capping for health and safety reasons.
(fig.7)

Exposed bolts and nuts to be capped.
