| <b>I. PRODUKTINFORMATION</b><br><b>PRODUCT INFORMATION</b> | | VORGANGSDATEN (KUNDE, EINGANGSDATUM USW.) SIEHE<br>TRANSACTION DETAILS (CUSTOMER, INHOUSE DATE ETC.) SEE | | <b>RMA</b> | <b>17/5169</b> | | | | | | | | | | | | | | | | | | | | | | | | |
| TYP / AUSFÜHRUNG / SERIENNUMMER / REVISION / SOFTWARESTAND – TYPE / MODEL / SERIAL NO. / REVISION / SOFTWARE<br>5 x OOM110 SN:V103005; V103329; V103330; V103471; V103760<br><br>Viamed | | | | | | | | | | | | | | | | | | | | | | | | | | | | | |
| REKLAMATIONSDESCHEIBUNG INKL. ANWENDUNGSUMGEBUNG – COMPLAINT DESCRIPTION INCL. CONFIGURATION OF APPLICATION<br>- Gas leaking through the sensor internally | | | | | | | | | | | | | | | | | | | | | | | | | | | | | |

**Complaint Sensors**

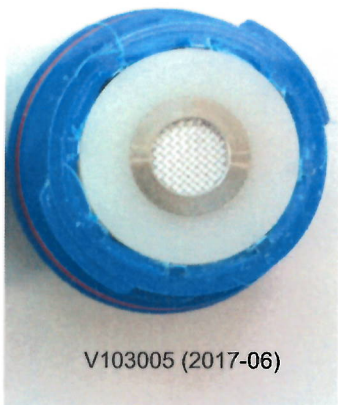
| SN | Build Date | Found Error |
|---|---|---|
| V103005 | 2015-12 | was open (out of warranty) |

| Build type | Build Time | Reason for Change |
|---|---|---|
| <p>V103005 (2017-06)</p> <p>Sensor with big inner Cell</p> | ... to 20.11.2015 | |

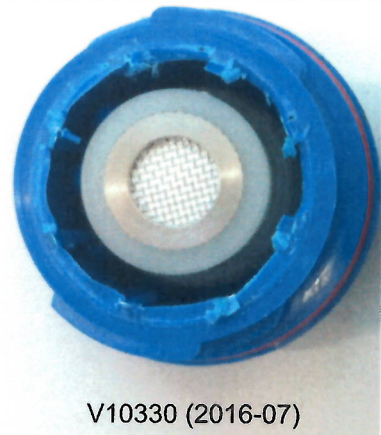
| SN | Build Date | Found Error |
|---|---|---|
| V103330 | 2016-07 | was open |

| Build type | Build Time | Reason for Change |
|---|---|---|
| <p>V103330 (2016-07)</p> <p>Sensor with small inner Cell without O-Ring</p> | From 20.11.2015 to 12.07.2016 | Implementation of product change to inner standard cell to improve product quality, life time and lead time. |

All product changes have been thoroughly tested, validated and approved. The design without O-Ring have passed the shock test at CE-Cert and a freefall test at EnviteC. The design change got the approval by Viamed at. 11.01.2016. On the basis of further experiences we implemented a corrective and preventive action to stabilize the position of the inner cell with a O-Ring. In accordance to our testing and product monitoring no leakage was observed since implementation of the CAPA.

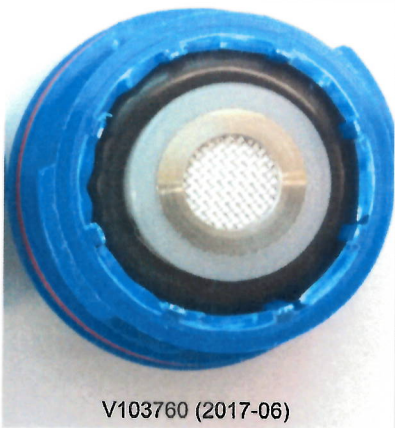
| SN | Build Date | Found Error |
|---|---|---|
| V103760 | 2017-06 | was open |

| Build type | Build Time | Reason for Change |
|---|---|---|
| <p>V103760 (2017-06)</p> <p>Sensor with small inner Cell with O-Ring</p> | From 12.07.2016 to now | Implementation of a centering ring as CAPA resulting from a customer complaint. The centering ring stabilizes the position of the inner standard cell and prevents the occurrence of leakages after mechanical shock or fall. |

| | ANDERE / OTHERS | | RÜCKWEISUNG WG. ANWENDERFEHLER /<br>REJECTED BEC. OF OPERATOR'S FAILURE |
| - | | | |
| <ul style="list-style-type: none"> <li>- No korrektive action needed</li> <li>- Designchange is done before we get a complaint.</li> </ul> | | | |
