Product Advisory Notice; Viamed Infant Resuscitation Cabinet

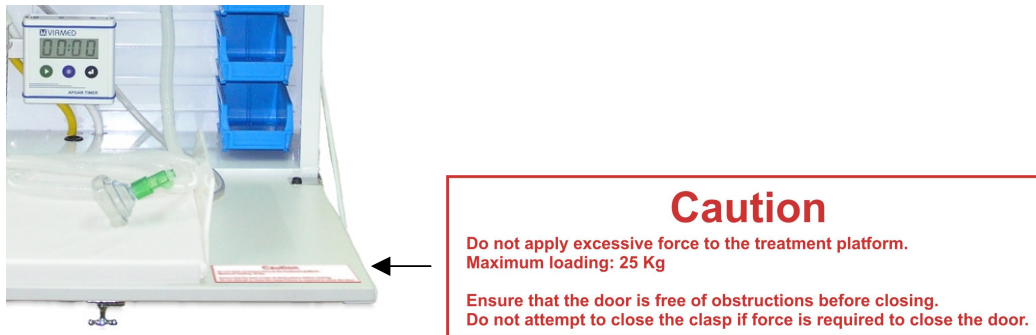
I have enclosed an advisory label, which should be affixed to the platform where it is clearly visible; we recommend that it be placed at the front of the platform adjacent to the bed.

The maximum loading is clearly stated in the Operator's manual. Users should be aware that the maximum loading, including pressure generated by the operators during use, should not exceed 25Kg. Additionally, the door must close freely; if significant force is required in order to close the catch, it is likely that there is an obstruction in the gap between the bottom of the cabinet and the door, which puts stress on the hinges and the door catch.
