Goods Receiving Report - Damaged Items

Purchase Order: POR12005
Supplier: Nufer Medical AG, Switzerland
Courier: Kuehne & Nagel Ltd
Date Received: 15th January 2019

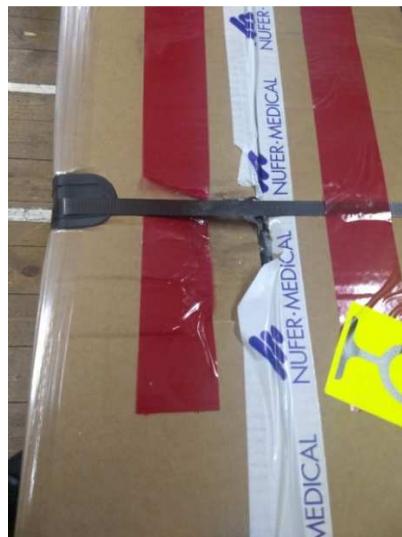
The pallet was received at Viamed on 15/01/19 in a damaged condition: the pallet exhibited clear evidence of having had another pallet stacked on top of it and a number of boxes on the top layer were crushed.

- 1) Request that Nufer Medical place the mains cable elsewhere in the packaging box, or remove them and ship them in a separate box.
- 2) Request to Nufer Medical that all future palletised shipments are fully shrink-wrapped (which also prevents water damage caused during depot transfers within the delivery chain) and to employ an anti-stacking measure, such as the as the cone illustrated below, or the simple addition of an empty box, positioned off-centre.

- 3) Advise Kuehne & Nagel of the damage caused by pallet-stacking and ask for their comments as to whether this is common practice in their delivery network.

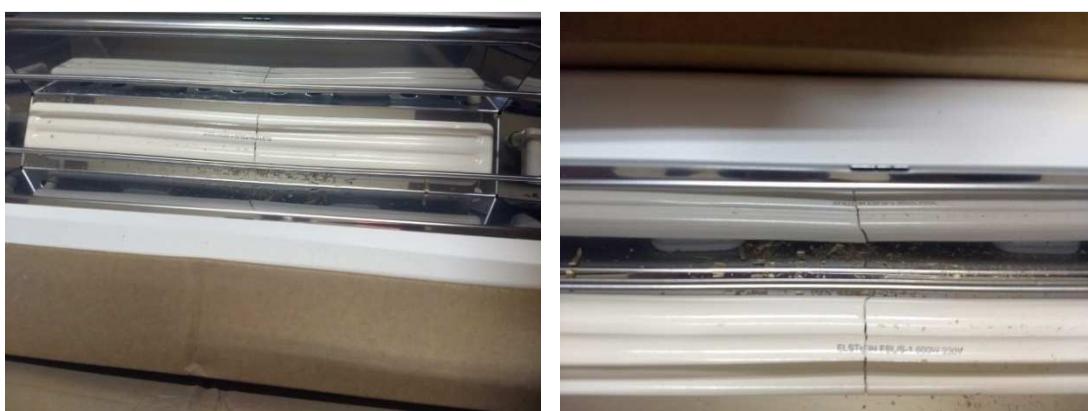
To determine the amount of damage, every radiant warmer was inspected and tested. One radiant warmer was found to have a damaged element, which was snapped in the middle.

A number of units were also found to contain wood-chip debris, providing further evidence of a pallet having been stacked on top.

The risk of damage to the element was increased due to the mains power cables being placed on top of the elements, allowing the compressing force to be transferred via the plug directly onto the Ceratherm element.

The pallet was only shrink-wrapped around the sides, allowing the wood-chips to enter the devices when the compressing force caused the box flaps to open inwards.
