Investigation into Customer Complaint CCR141

Customer: Theatres, New Cross Hospital
Date reported by customer: 27th June 2011.
Date of this report: 4th July 2011
Author: Steve Hardaker, UK Sales Manager

Nature of complaint

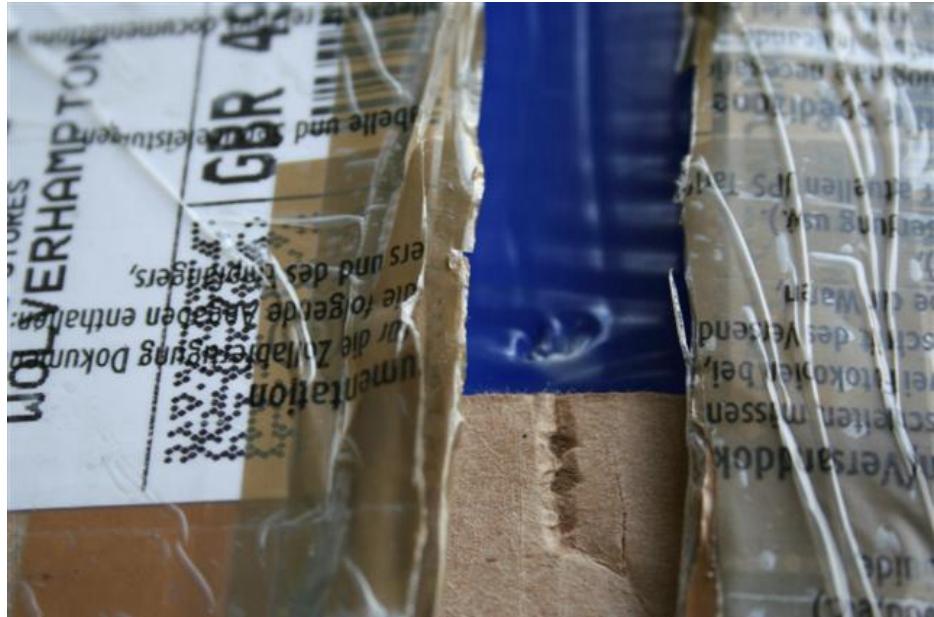
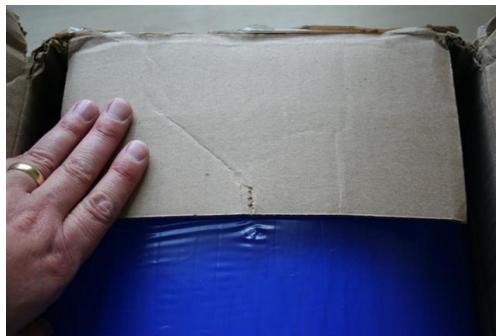
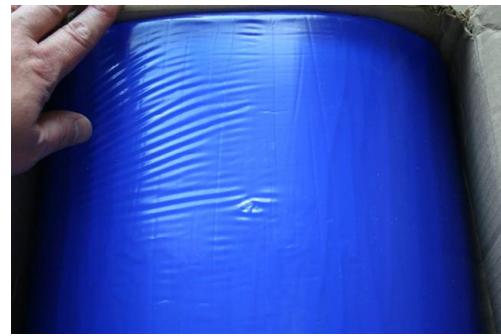
This revealed that the damaged area on the gel pad corresponds exactly with the edge of the inner cardboard flap, which also shows signs of damage. This suggests that an implement was used to open the box, causing damage to the gel pad.

It can be seen that the damage begins at the point on the mattress corresponding exactly to where the flap ends, which protected the area of the pad beneath the flap.

Viamed have concluded that the damage was almost certainly caused by the use of a semi-sharp implement to open the box upon receipt at the Trust. This implement was most likely not a blade due to the rough tearing evident on the parcel tape and on the inner cardboard flaps: a blade would have generated a clean cut, whereas the parcel tape and cardboard flaps display a distinctly ragged incision.

This type of damage is not covered by the product warranty. As a goodwill gesture, Viamed will offer to repair the damage free of charge using the manufacturer's repair kit, which is designed specifically for the task. This comprises a patch of the same material used for the skin of the gel pad, bonded to the surface over the damaged area.

For future orders to this Trust, Viamed will be inserting layers of cardboard in the top and bottom of the shipping boxes in addition to the layer of bubble wrap, and will put an advisory caution sticker on the outside of the box advising care when opening.

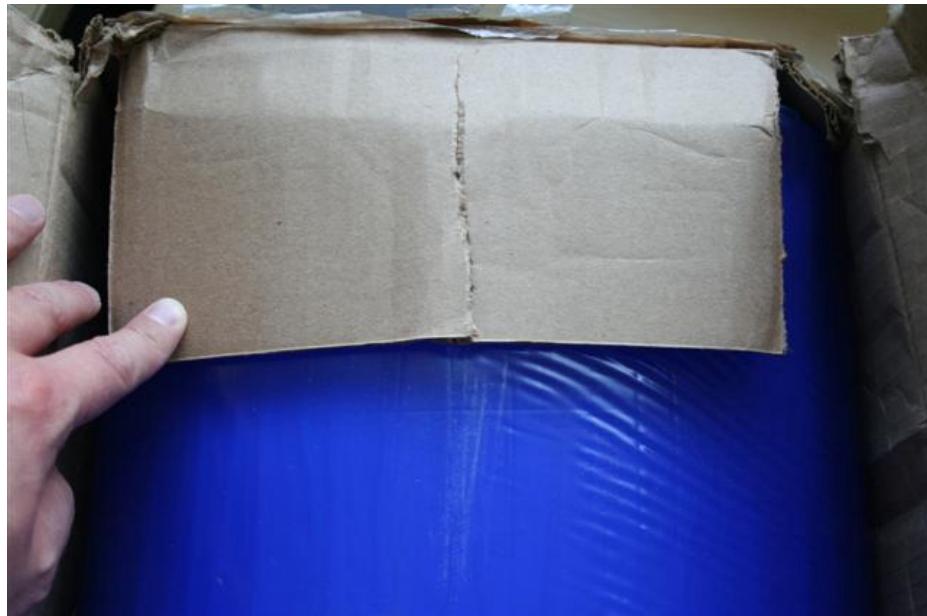
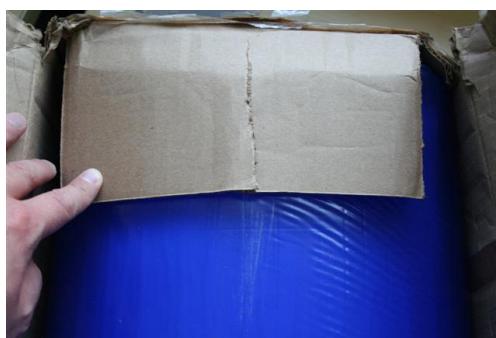
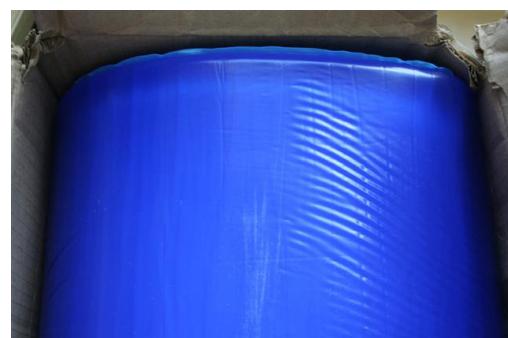
Further evidence can be seen from the other end of the box, which has similar damage to the inner cardboard flap corresponding exactly with the position of slight scuffmarks on the gel pad where the implement used to open the box has run off the flap onto the pad.
