Test data for acquired OEM Dräger Spirolog 8403735 flowsensors

The following test data relates to flow sensors acquired from various sources.

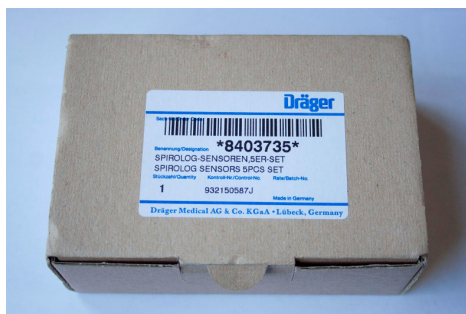
Table 1 is a box of unused flowsensors believed to be of a previous generation. The box bears no CE marking or manufacturing date, it states “Made In Germany”. No instruction insert was received.

OEM Dräger Spirolog 8403735 (old style – cylindrical)				
Dräger Control Number	No.	Test results @23C		
		Top	Bottom	Difference
932150587J	1	3.514	3.476	0.038
932150587J	2	3.477	3.514	0.037
932150587J	3	3.395	3.532	-0.137
932150587J	4	3.445	3.444	0.001
932150587J	5	3.599	3.506	0.093

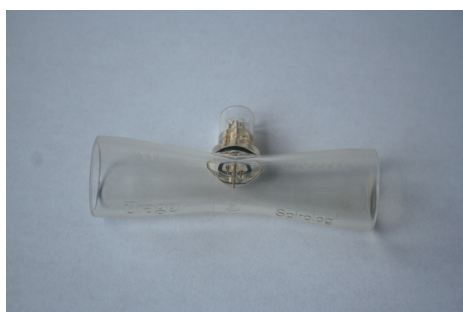
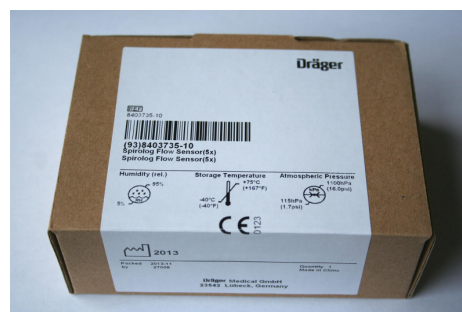
Table 2 is a box of unused flowsensors of the most recent generation. The box bears the CE mark, a manufacturing date of 2013 and a packed date of 2013-11. It states “Made In China”. The box contained instruction insert Edition 8, dated 2011-09.

OEM Dräger Spirolog 8403735-10 (new style – with narrow waist)				
Packed date	No.	Test results @23C		
		Top	Bottom	Difference
2013-11	1	3.343	3.320	0.023
2013-11	2	3.404	3.377	0.027
2013-11	3	3.324	3.350	-0.026
2013-11	4	3.393	3.338	0.055
2013-11	5	3.358	3.371	-0.013

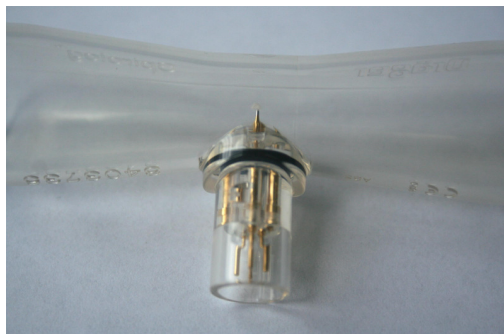
Table 3 is 2 individual flowsensors of the most recent generation. Sample 1 was obtained from a UK hospital and is unused. Sample 2 is from a hospital in the Middle East and is used. Both look identical and have a black plastic ring at the point where the connector stem meets the body of the flow sensor.

OEM Dräger Spirolog 8403735 (new style – with narrow waist)				
	No.	Test results @23C		
		Top	Bottom	Difference
Unspecified (unused)	1	3.323	3.377	-0.054
Unspecified (used)	2	3.373	3.395	-0.022
