Royal Preston Hospital - Servicing visit summary, March 2014

Order ref: 226211475

Location: Sharoe Green Unit, Delivery Suite (12 systems) and Maternity B (1 system)

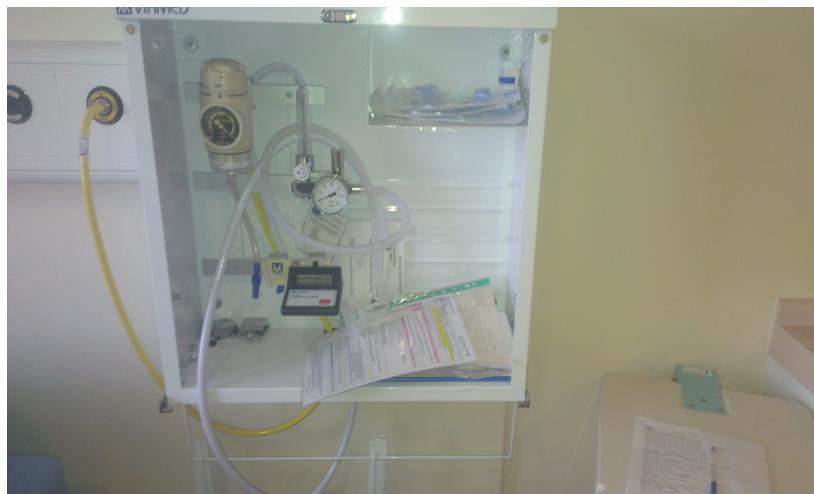
Room 5

Resuscitation cabinet s/n D099 - the cabinet has no door. Replacement cabinet body is required. A quotation has been issued for the supply of a cabinet body complete with equipment rails and a bed. Ref. QUO03620, dated 21/3/14.

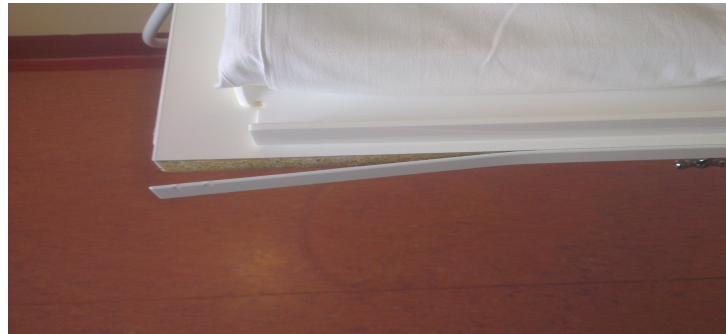
Room 3

Resuscitation cabinet s/n D007 - the edging strip on the door is peeling back on the leading edge. This is a primarily a cosmetic issue and does not affect the structural integrity of the cabinet, however, it may affect the ability to clean the cabinet effectively and may pose a minor risk of injury to a user.

Subject to a risk assessment by the Trust, it may be possible to glue the strip back in place with suitable glue. If repair is not considered appropriate, a replacement cabinet body offers an alternative solution.

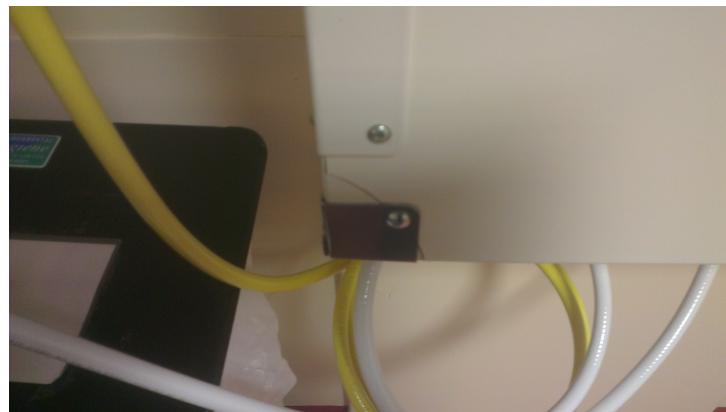
Outside view

Resuscitation cabinet s/n D007 - has a crack across the door at the hinge, visible on the outside but not on the inside of the door. Because of the age of the cabinet we can only offer a new cabinet body as a repair but subject to a risk assessment it may be possible to repair the door.
