Temperature Sensor Failure Report

Related issues: #83057, #80450

Stock reference: 0212030

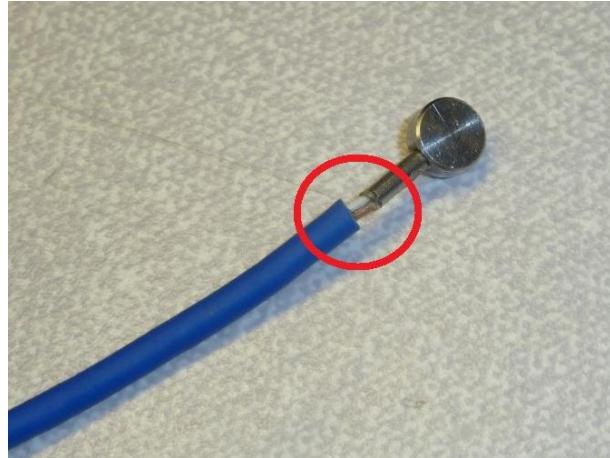
SN: V150110407 – The temperature sensor has been tested. The sensor is open circuit. The sensor head has come away from the cable, but remains attached by the braiding and internal wiring.

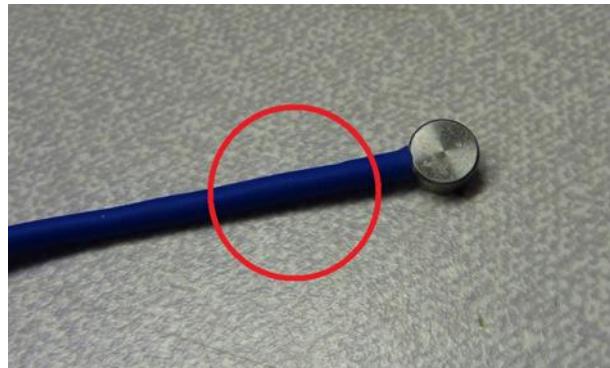
SN: V150110480 – The temperature sensor has been tested. The sensor is open circuit. The cable at the sensor head feels empty. It is likely that the sensor head has come away from the wiring.

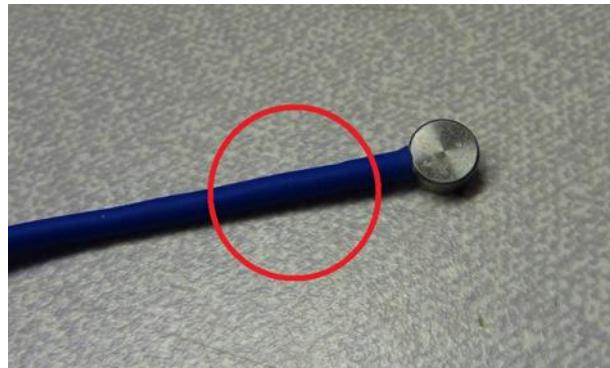
SN: V150110481 – The temperature sensor has been tested. The sensor is open circuit. The cable at the sensor head feels empty. It is likely that the sensor head has come away from the wiring.

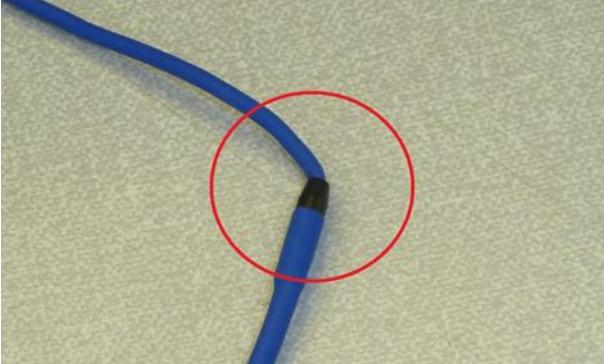
SN: V140110383 – The temperature sensor has been tested. The sensor is open circuit. There is an intermittent break at the cable joint. There seems to be internal damage to the cable at the marked points.
