From: "Chris Morgan"
To: "Steve Hardaker" <shard@viamed.co.uk>
Sent: Wednesday, May 22, 2002 5:24 PM
Subject: RE: Viamed - catches for BA/10 cabinet

From: Steve Hardaker [mailto:shard@viamed.co.uk]
Sent: 22 May 2002 16:57
To: Chris Morgan
Subject: Viamed - catches for BA/10 cabinet

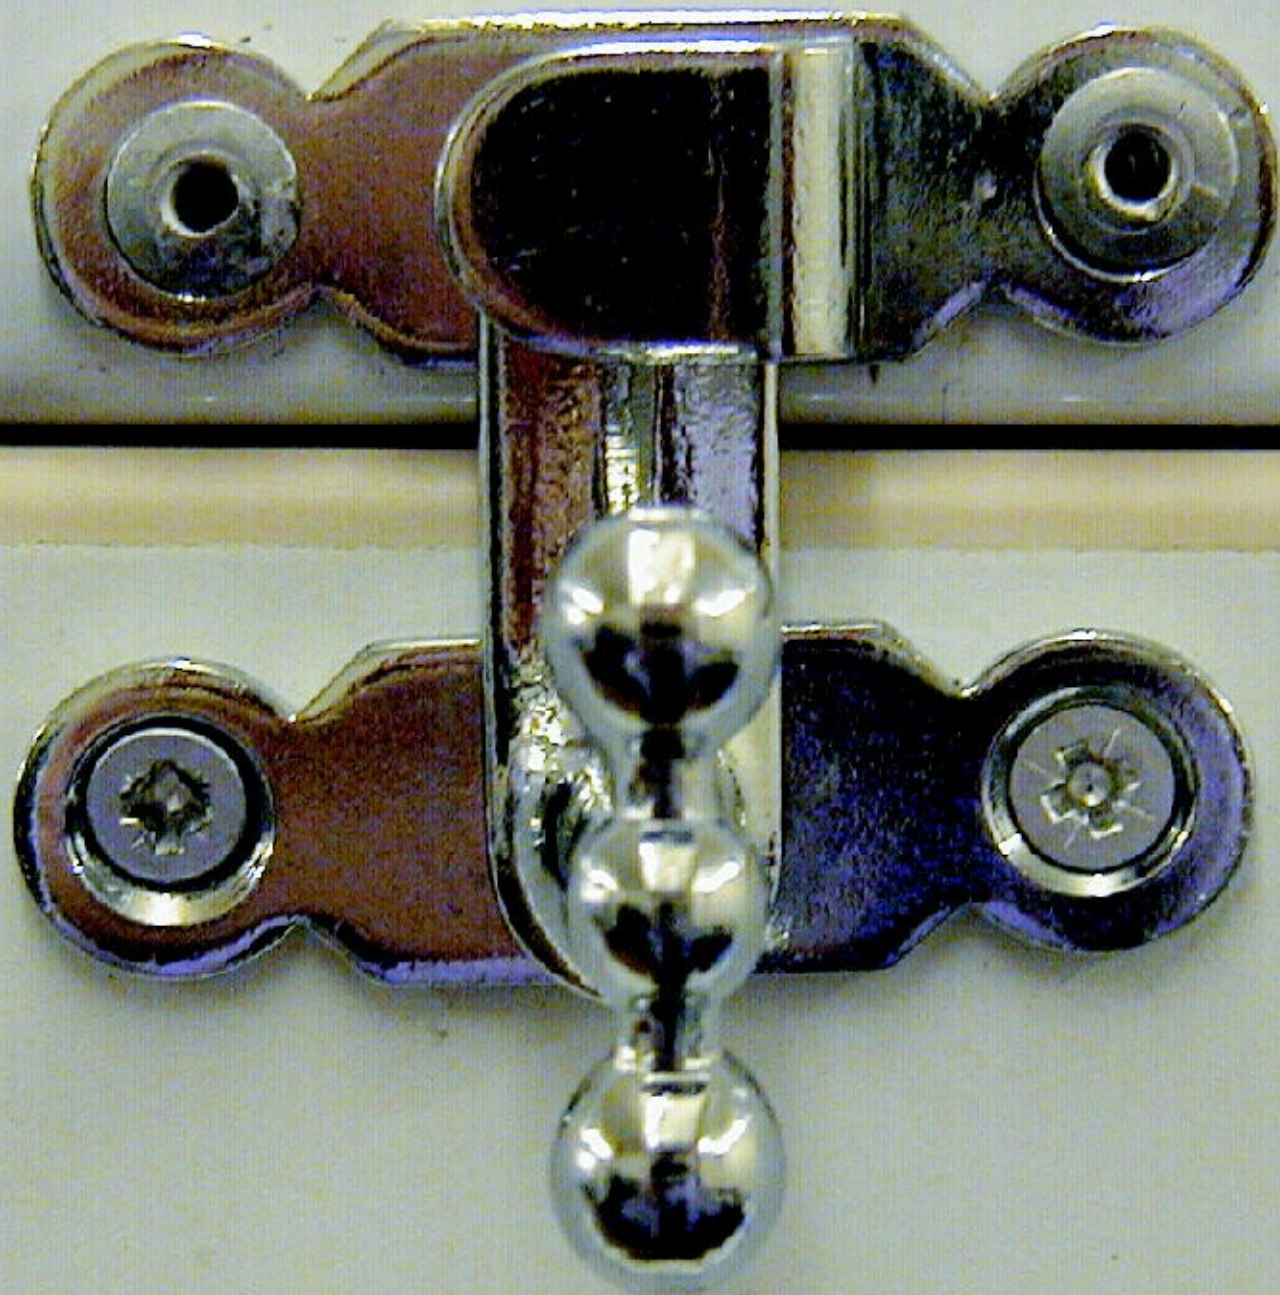
Chris as discussed the picture attached shows a scan of the 2 different types, the left has a washer between the moving parts and the one on the right does not.

We currently have in stock 10 cabinets that have the type without washers and we are receiving reports from customers that these are causing problems by being loose allowing the door to open unexpectedly, others are simply breaking off.

Sincere apologies for the problems, and thanks for your trouble taking the photo - we are ensure that future cabinets, including the ones coming to you next week will be OK.

Also arranging to send 10 catches to you.

I would be grateful if you could ensure that future cabinets have the catches with washers. Also would it be possible for you to send me a box of these to replace the catches on the 10 units we have in stock of this type?
